Landslides (2011) 8:309–320
 DOI 10.1007/s10346-010-0249-1
 Received: 6 December 2009
 Accepted: 2 December 2010
 Published online: 11 January 2011
 © Springer-Verlag 2011

Jan Klimeš · Vít Vilímek

A catastrophic landslide near Rampac Grande in the Cordillera Negra, northern Peru

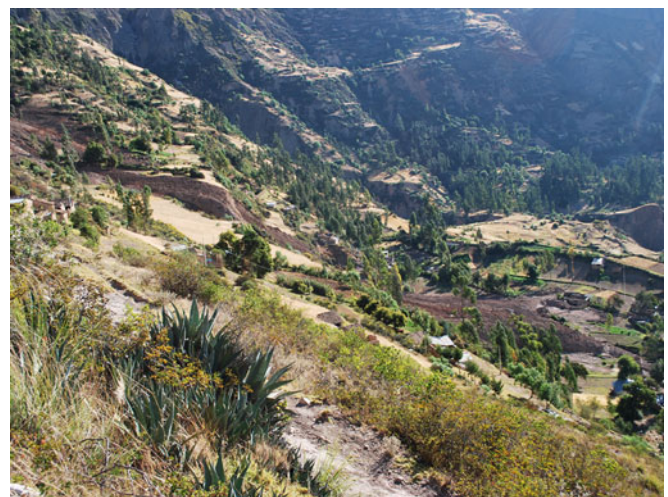
Fig. 2 General view of the transport (*f* in Fig. 4) and accumulation (*l*, *k* in Fig. 4) part of the landslide. Approximately in the middle of the figure, distinct break in the slope can be seen. Below the accumulation zone, one of the endangered houses can be seen

Transport part (Fig. 4e, f) of the landslide starts below the zone of depletion showing signs of high mobility of the material and also, in some parts, of its flowing rather than sliding (Fig. 4f). It is indicated by the empty source area shown on Fig. 4 as minor scarp and presence of a levee along its channelized transport path with a height of up to 1 m. High mobility of the landslide material

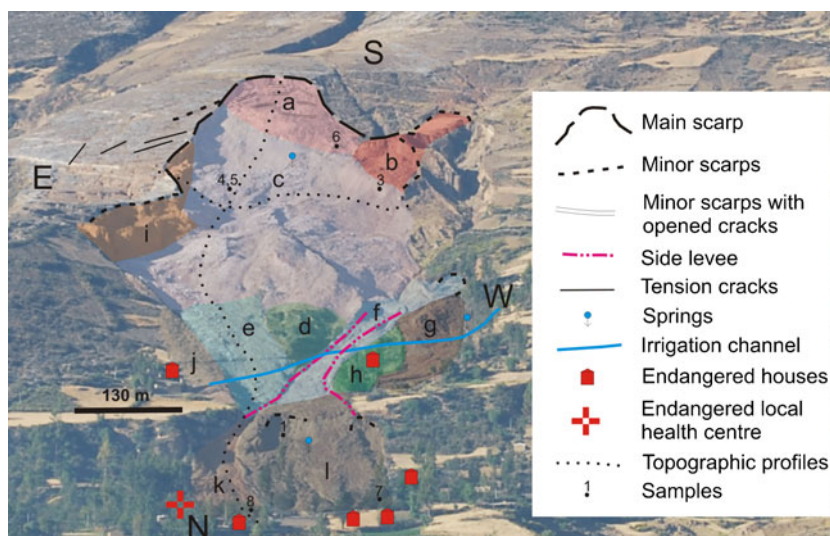
Field geomorphological research done in July 2009 enabled us to describe the main landslide forms and hydrological features. They are shown on a “photomap” based on the panoramic view of the studied landslide from the main square of the Carhuaz town. Interview of the local inhabitants enabled us to describe the landslide event itself. Longitudinal and transversal topographic profiles of the landslide were constructed using a LaserAce inclinometer device. Seven samples of the landslide material were taken from its surface for later granulometric and clay mineral analysis. Two samples are derived from the scarp (sample nos. 3 and 6), three from the transported zone (samples nos. 1, 4, and 5), and two from the accumulation zone (samples nos. 7 and 8; Fig. 4).

Fig. 4 Oblique photo of the studied landslide with the main landslide features. Letters indicating different parts of the landslide are described in detail in the text

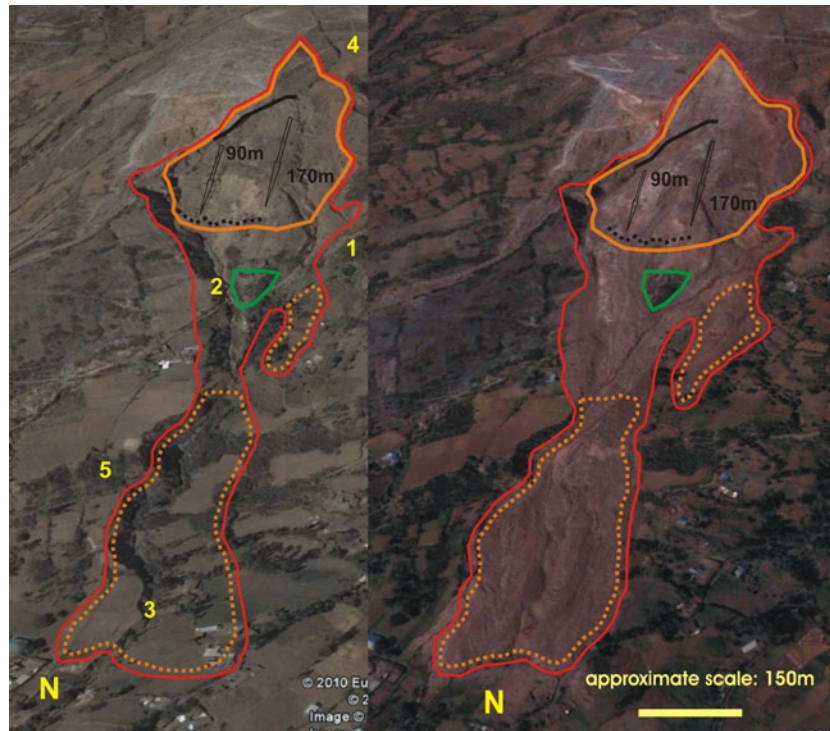
The geomorphological conditions prior to the landslide have been examined using existing topographic maps and GoogleEarth imagery (Fig. 5). The imagery clearly shows the material stored in the source area that was mobilized during the landslide. The slope has been interrogated using a digital elevation model with a horizontal resolution of 30 m. The average slope angle is 26° with a standard deviation of 6°. The maximum slope angle is 43°, and the minimum is 10°. The eastern boundary of the landslide is terminated by a steep ravine (no. 2 on Fig. 5). This ravine forms an important local tributary for the Atun Stream. During the landslide, it served as a conduit channel for the displaced material. The material partly filled the ravine and accumulated on both sides (no. 3 on Fig. 5). The buried ravine still has a surface expression in form of 2 m deep “V” shaped gully, which divides the accumulation into two distinct lobes. A second ravine cuts through the source area of the landslide (no. 4 on Fig. 5). This merges with the first ravine on the lower part of the slope that was destroyed by the landslide. This second ravine changes its direction sharply twice within its length of 350 m. It follows the general northwesterly trend of the local fault and lineament systems. This suggests there may be an underlying structural influence in the vicinity of the study site. The western boundary of the landslide lies close to another gully. Again, the sides of the gully were remodeled by the landslide.

Fig. 5 Comparison of GoogleEarth satellite image before the landslide event (left) and after the event (right). Orange solid line zone of depletion; orange dashed line zone of accumulation; black solid and dashed lines displacement of the upper part of landslide; numbers indicating horizontal displacement; green solid line area with least displacement; 1 artificial lake; 2 and 4 ravines; 3 accumulation area along the ravine; 5 distinct break in the slope

distinct break in the slope is marked by green vegetation (no. 5 on Fig. 5). This break is also seen on the geomorphological map (Fig. 3). It maintains an elevation of between 2,990 and 3,090 m asl and runs for a length of 1.7 km. The break is interpreted to be the morphological expression of contrasting lithologies.

The area subjected to the least displacement is located within the green limits in Fig. 5. Fieldwork has indicated that this middle sector of the landslide was its least active part and that, only surface material has been moved.

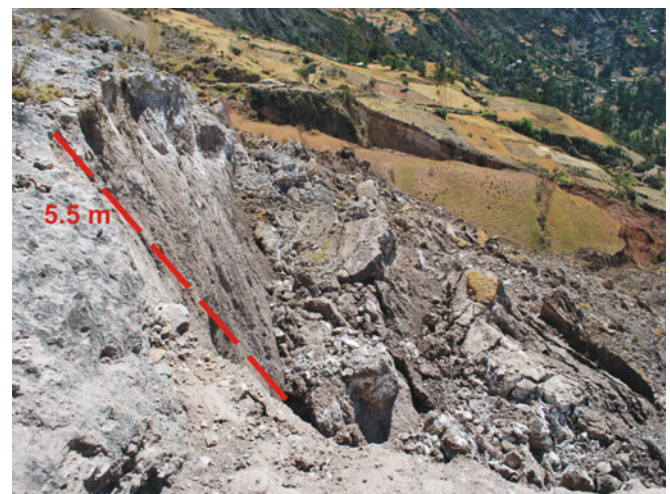
The main scarp is about 5.5 m high followed by number of minor scarps with opened transverse cracks in some places 0.5–m wide (Fig. 7). The cracks separate blocks of loosened rock material (including block of hard rock–argillite shale and carbonate rocks). Block surfaces are slightly back-tilted with rather well-preserved original surfaces with vegetation (Fig. 4a). Mainly vertical movement with minor horizontal displacement occurred there. The

Fig. 7 Main scarp of the complex landslide (*a* in Fig. 4) with well visible minor scarps with opened cracks and rock blocks with slightly back-tilted surfaces

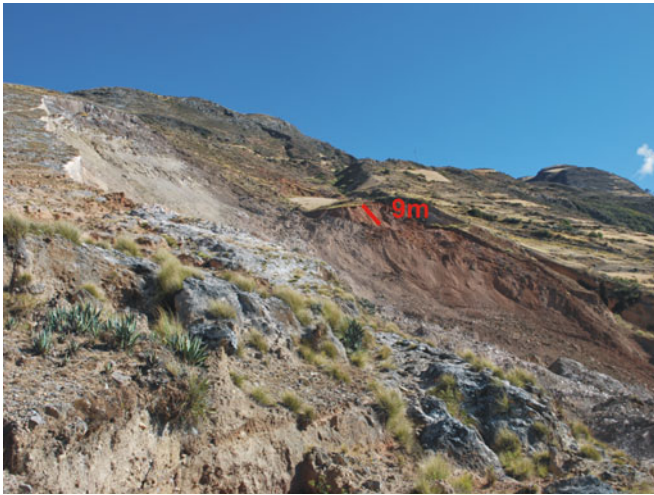
northwestern lower end of the main scarp area is pushing to the block of reddish argillite rocks with 9 m high main scarp (Fig. 8) and estimated volume of $35,000 \text{ m}^3$ (Fig. 4b). It bears evidence of previous sliding activity as there are old scarps and filled tension cracks on its margins. The stress caused by pushing the material under the main scarp against the rock block, along with unloading of its toe, contributed to the reactivation of this part of the landslide scarp. Sliding continued further down slope for some 280 m below the main scarp (Fig. 4c). A large majority of the landslide material was mobilized from this zone of depletion. Less deep sliding with rather short run-out was observed in the lower part of the zone of depletion bordering with the part *d* of the landslide (Fig. 4). This landslide part is largely free from the pre-landslide conditions on the satellite images suggest that this area underwent just a minor movement, if any.

Fig. 8 General view of the main scarp and depletion zone of the landslide (*a*, *b*, and *c* in Fig. 4) from east to west

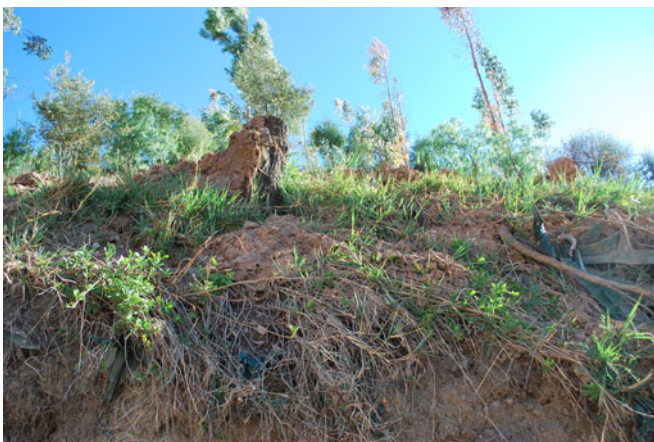
is evidenced by the fact that part of the material was transported aerially on top of the stable ground (Fig 9, Fig. 4g). The maximum measured length of earth flow material transported through the air is 56 m with a vertical exaggeration of 26 m. It is pertinent to note that a house located outside the landslide area (Fig. 4 description *h*) was badly damaged by stones which fell on top of it, destroying mainly its roof (Fig. 10). Around the house, splashes of mud and “exotic” stones with diameters of up to 0.4 m were found on otherwise undisturbed ground and vegetation. Furthermore, tree branches were broken up to 3 m above the surface of the landslide (Fig. 11). Distinct side scarps 7 m high detached rock blocks (Fig. 4j) which formed part of the east landslide limit. The largest rock block has estimated volume of 27.000 m³. The toes of these blocks are partly covered by transported material, so the original depth of the ravine on which side the slide blocks evolved could be only estimated to 11 m.

Fig. 9 Splashes of landslide material on stable ground (*g* in Fig. 4) indicate that the material came from *left* to the *right* of the photo

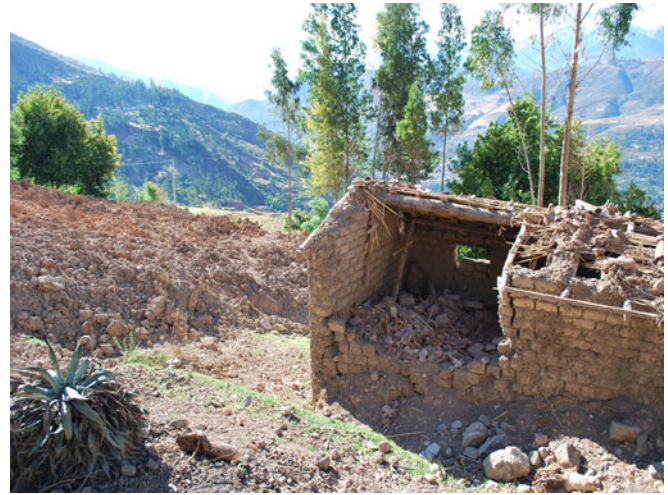
Fig. 10 Farm house destroyed by stones transported aerially (*h* in Fig. 4). Accumulation with depth up to 1.8 m (*g* in Fig. 4) can be seen *left* from the house

the limits of the closest house. Another accumulation was deposited on the opposite side of the landslide (Fig. 4g), covering an area of about 7,200 m² and reaching the thickness of 1.8 m. The main accumulation area (Fig. 12, Fig. 4k, l) has thickness ranging from 0.5 to 7 m. It destroyed one house and stopped 25 m from another house and 36 m from the local health center. It formed two distinct lobes separated with up to 2 m deep ravine. Its material was washed out on its sites as well as along its toe covering areas previously free of the landslide material. Deposition of material up to 0.3 m develops in this way. Before reaching

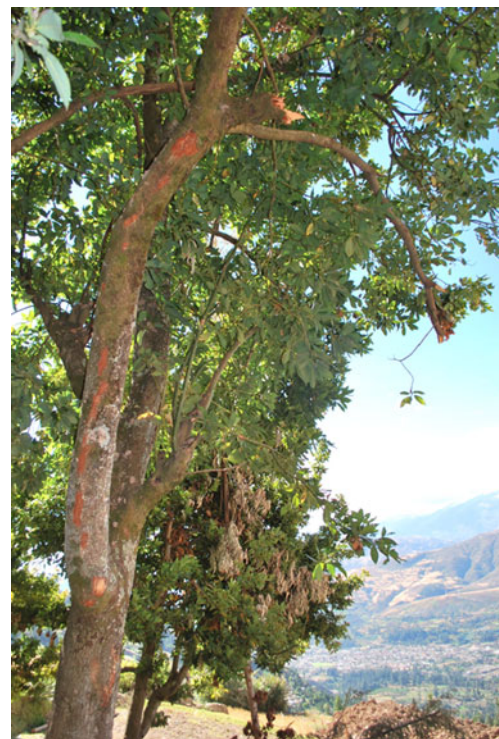
Fig. 11 Note scars on the trunk and broken branch of the tree caused by landslide material. It is located just on the border between parts *f* (assumed earth flow) and *h* in Fig. 4

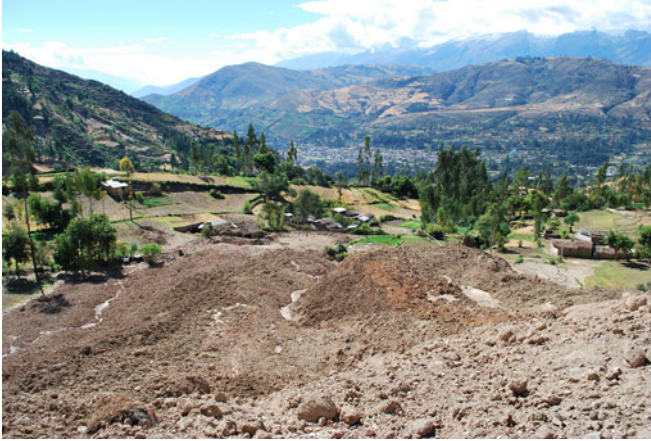
Fig. 12 Accumulation area of the landslide with two distinct lobes (*l* and *k* in Fig. 4). This part of landslide caused largest damage

the accumulation area, the material overcame the distinct break in the slope (with slope angle of 40°) where two small (about 10 m high) slides with well visible shearing planes developed.

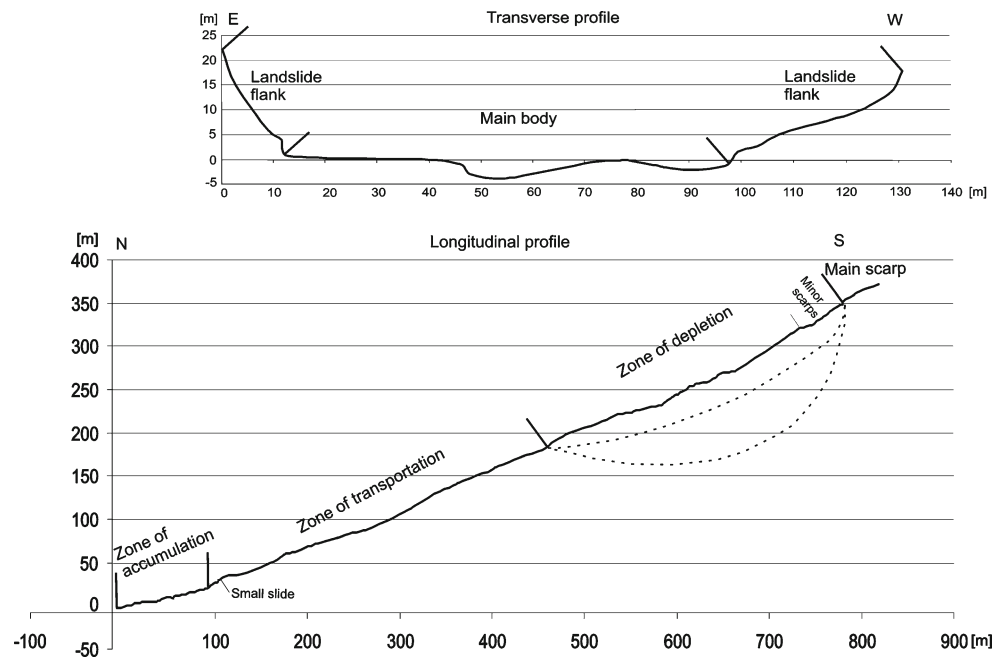
Estimated depth of the main surface of rupture is between 50 and 100 m in the place of the topographic profile (Fig. 13). Their depths and shape were determined uniquely interpreting the profile data, landslide morphology (identification of the toe of surface of rupture), and basic assumption that the landslide moved along mostly planar shear plane. It is probably rotational near the main scarp (Fig. 13). Further downslope, no evidences of rotational shape

Fig. 13 Longitudinal and transverse topographic profile of the landslide. Note the main landslide parts and suggested surface of rupture. The profiles are not elevated. Their location is shown in Fig. 4

of the shear plane were found. The 50-m depth of the surface of rupture may, at least in some parts of the landslide, overestimate the actual landslide depth. Thus, the deeper estimate (100 m) is rather a scenario for the case that the surface of rupture would be rotational, which we think is less probable. The longitudinal profile also shows that the zone of depletion is disrupted by local ridges and depressions which are usually conform to the landslide longer axis.
