The 1916 catastrophic flood following the Bílá Desná dam failure: The role of historical data sources in the reconstruction of its geomorphologic and landscape effects

Pavel Raška^{a,*}, Adam Emmer^b

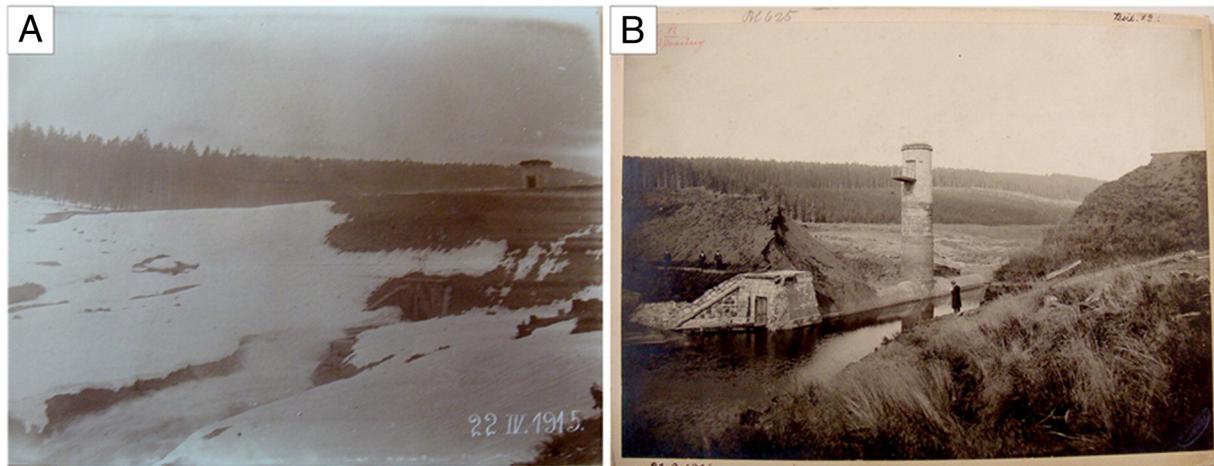
Fig. 4. Upstream view of the Desná dam before (A) and after (B) the dam failure. Source: Archive of the Jablonec nad Nisou, Court reports.

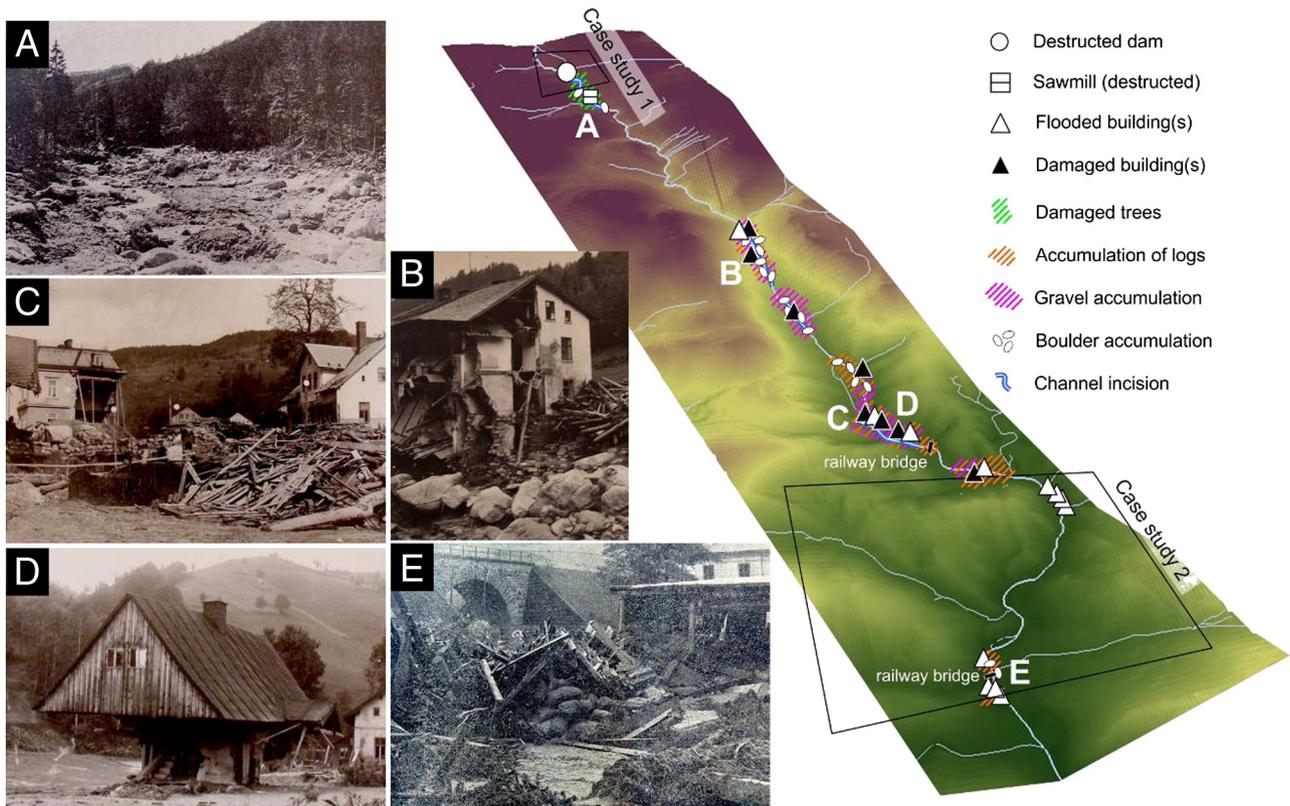
Fig. 6 shows the identified effects of the flood along the river between the failed dam and the town of Tanvald. The detected effects include (i) damage to buildings and to infrastructure and (ii) modifications of the river channel (erosion and accumulation processes), and their intensity can be divided into three segments relative to the longitudinal profile of the Bílá Desná River (Fig. 1D). More than one-third of the studied river length (0–3.2 km) is situated in a narrow intra-mountain valley, with an average slope inclination of ca. 2.80° (806–650 m asl).

Fig. 6. Effects of the flood along the Bílá Desná River based on documentary data. Note: Of the large amount of documentary data, only those data that could be exactly localised were used.

The high gradient of this river segment enabled the stream to transport a large amount of material, which consisted of fractions varying from sand to boulders of up to 2 m in diameter. The flood wave damaged the forest ecosystem in the narrow valley, and the channel underwent a lateral shift (see below in case study 1) and a slight incision in some segments. After reaching the end of the narrow valley, the Bílá Desná River reaches the open space with the settlement of the village of Desná. Between 3.2 and 5 km, the gradient slightly increases to ca. 3.8° as the river channel enters the foothills; however, this gradient gradually decreases from 5 km downstream. The decrease in the gradient, which causes a loss of flow velocity, resulted in the gradual, but massive, deposition of boulders and of timber (approximately between B and D in Fig. 6) that damaged or destroyed tens of buildings, including a few industrial facilities (Gnendiger, 1920) in this river segment. The woody buildings localised near the channel and in the open floodplain (D in Fig. 6) were primarily affected. Owing to the transformation of the flood wave, the last analysed segment of the river (approximately within case study 2) was primarily affected by flooding; however, the destruction of buildings was not frequently documented. This lack of documentation can be ascribed to not only the increasing share of buildings constructed from stones and bricks in this segment but also the decreasing volume of boulders and timber that reached the lower parts of the river. In contrast, the documentary evidence has shown that part of this transported material (both timber and boulders) reached as far as the railway bridge in Tanvald (E in Fig. 6), ca. 8 km below the failed dam.

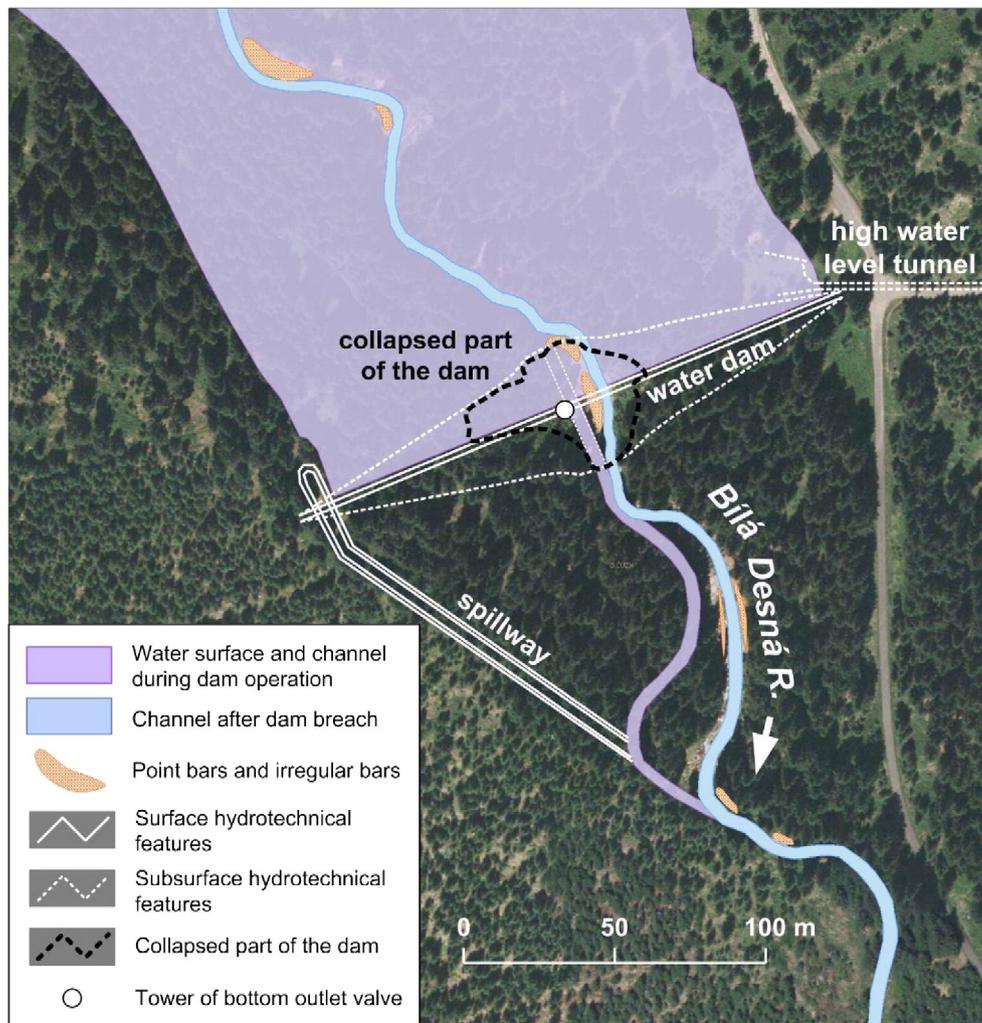
4.1.3.1. Case study 1. The disturbance and modification of the valley and riverbed of the Bílá Desná River following the dam failure has been reconstructed in case study 1, which covers the area of the former reservoir (see Fig. 1). The detailed reconstruction of other river reaches could not be performed because of the limited availability of old maps and photos. Following the dam failure and the rapid discharge of 250,000 m³ of accumulated water during only 30 min, the channel below the dam was significantly modified. The comparison of historical maps from investigation reports of the event and of aerial photos from the early 1950s and from 2010 has shown that the meandering channel below the dam was subject to channel migration and lateral accretion (Fig. 7). The channel width in the reach below the former reservoir varied around 5 m before the dam failure and is currently 8 m in average. The magnitude of channel migration reached up to 30 m in the second meander below the former dam, whereas the lateral accretion only slightly increased the sinuosity of the channel. Instead of channel straightening (cf. Pizzuto, 2002), which could be expected as a result of flood wave flow, the return to the original meandering channel seems to be caused by geometry of a dam-breach and by extreme discharge that disrupted the channel geometry artificially established during the dam construction. This seems to be caused by the disrupting impact of the flood wave caused to channel segments. As documented by cadastral maps from the mid-nineteenth century, the Bílá Desná River channel approximately returned to its original position before the dam construction, with a meandering pattern. The reestablishment of the meandering

Fig. 7. Changes in the channel morphology after the dam failure.

channel pattern and increased sinuosity by lateral accretion enabled the evolution of several gravelly points and irregular bars, which are characteristic of other high-gradient streams in the area. According to Costa and O'Connor (1995), the above-described geomorphic changes are characterised as ‘extreme disruptions’ of the river channel.

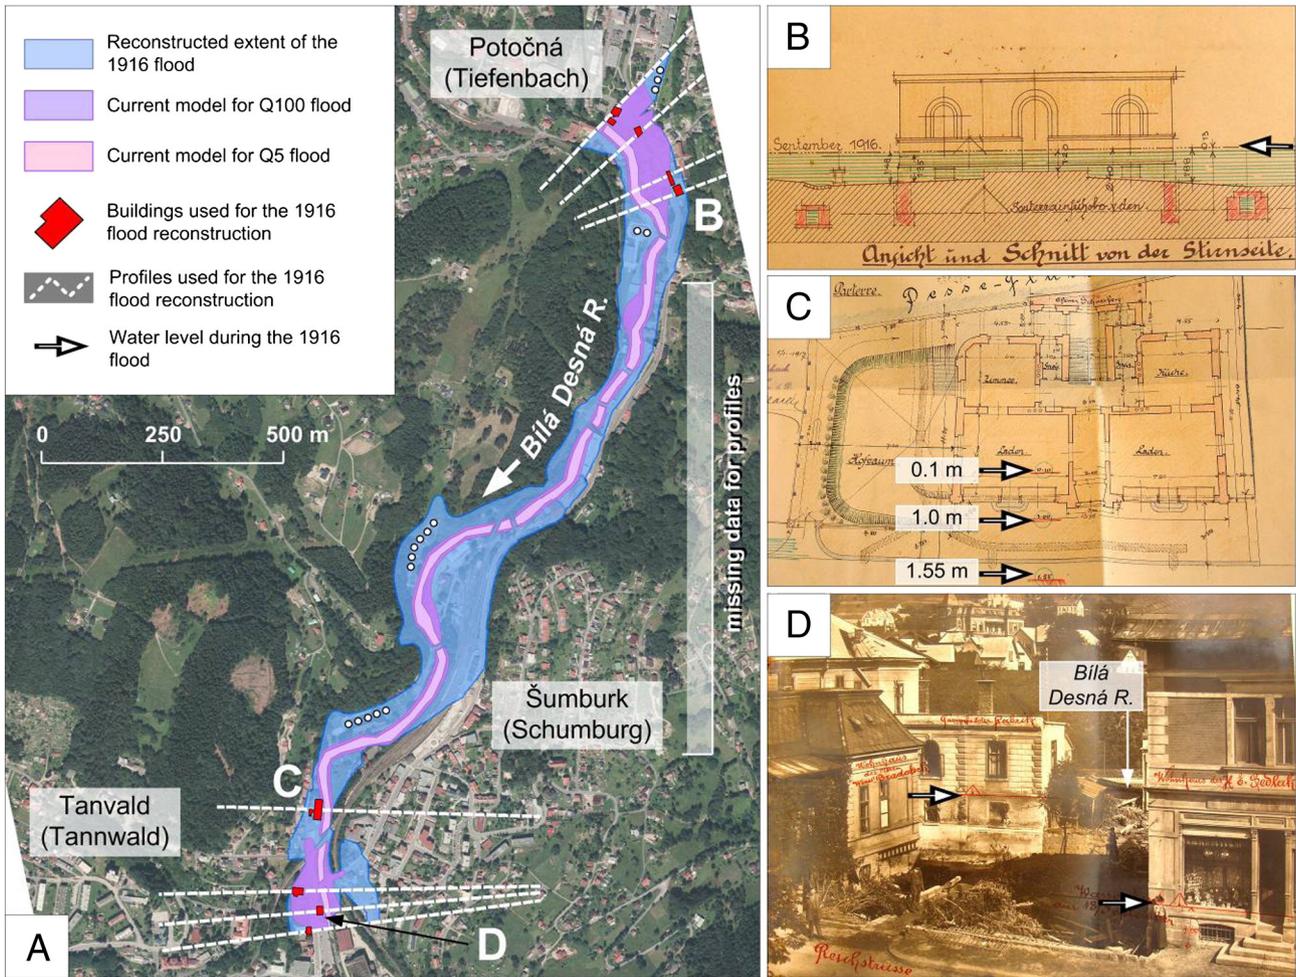
The width of the flooded area ranged between ca. 50 and 250 m, with the highest width reached in built-up areas of the towns and in the meandering channel in the central part of the studied channel reach. In contrast, the minimal width was typical of narrow valley segments, where an increase in the flow velocity can be expected. However, the documentary data did not provide the cross profiles for the central part of the studied river reach. Therefore, the results for this part of the area must be considered only rough estimations. According to the classification presented by Costa and O'Connor (1995), this part of the Bílá Desná River channel was affected by ‘small disruptions’ from the point of view of geomorphic impacts.

Fig. 8. Estimated flood wave extent. Part (A) illustrates the flood wave extent and the Bílá Desná River valley cross profiles. White dots for major changes in built-up areas after 1916 within the estimated flood wave extent (see Section 4.1.3 for further explanation). Examples of documentary evidence for the flood wave extent and the water level, as preserved in investigation reports for insurance companies. Cross-profile (B), plan (C), and photo (D) with an indicated water level mark.

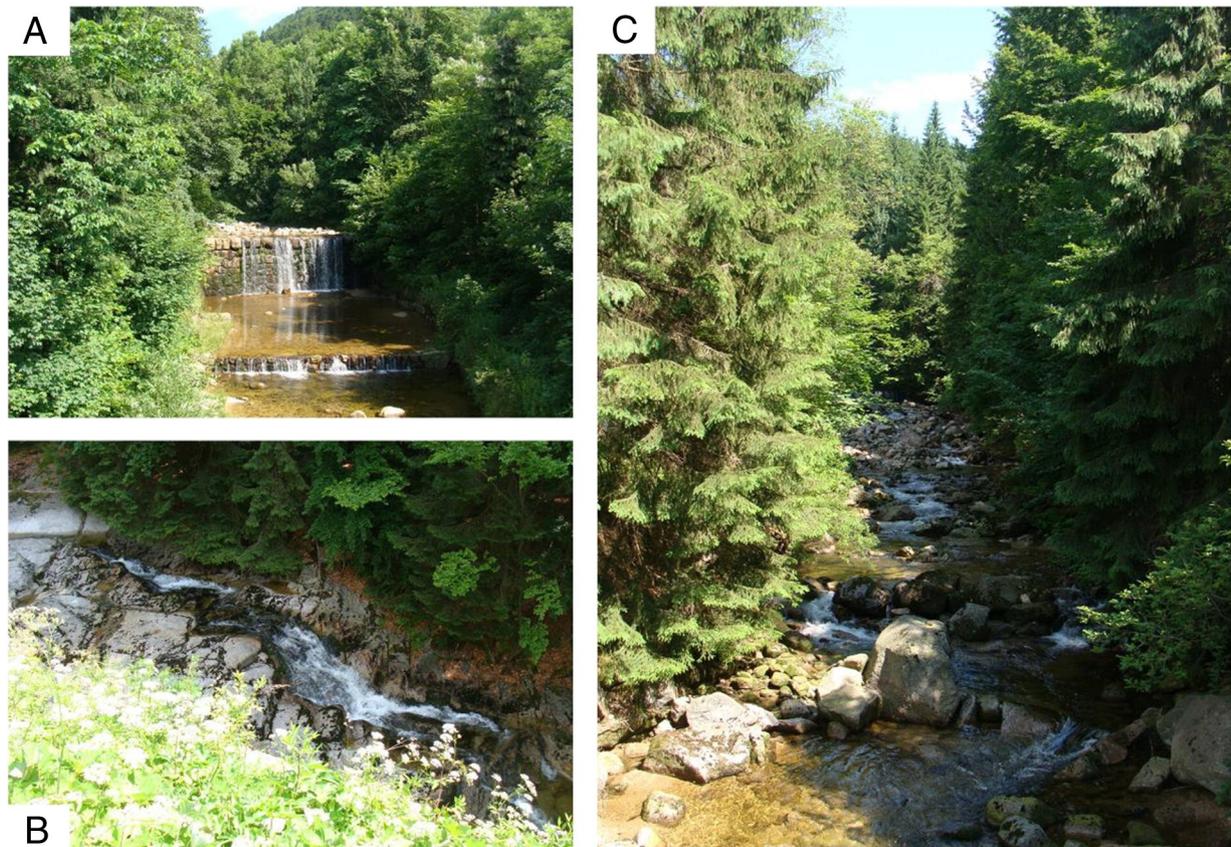
Fig. 9. Part (A) shows an example of stony steps built into the steeper part of the Bílá Desná River channel to protect against floods (debris flows). Part (B) shows a natural bedrock-based part of the river channel bottom. Part (C) shows a natural (unremediated) part of the Bílá Desná River channel.

modified between 1923 and 1936. These technically demanding and expensive remedial works included the complete pavement of the river bottom along the 1.5-km-long lower part and the construction of 34 stony steps in the steeper 2-km-long upper part (Fig. 9A); bedrock-based parts of the river bottom were left without modifications (Fig. 9B). The stony steps are between 1.0 and 4.2 m high and 11.0 to 18.0 m long and serve as a sediment trap (prevention against the initialisation of debris-flow movement). All of these artificial elements are designed for a maximal flow rate of $60 \text{ m}^3 \text{ s}^{-1}$ (Žák, 1996). The section from the upper part of the village of Desná to the former Desná dam position has a natural character, with no artificial channel modifications (Fig. 9C).
