# *The ICL Network on “Landslides and Cultural & Natural Heritage (LACUNHEN)”*

Journal of the International Consortium  
on Landslides

## The ICL Network on “Landslides and Cultural & Natural Heritage (LACUNHEN)”

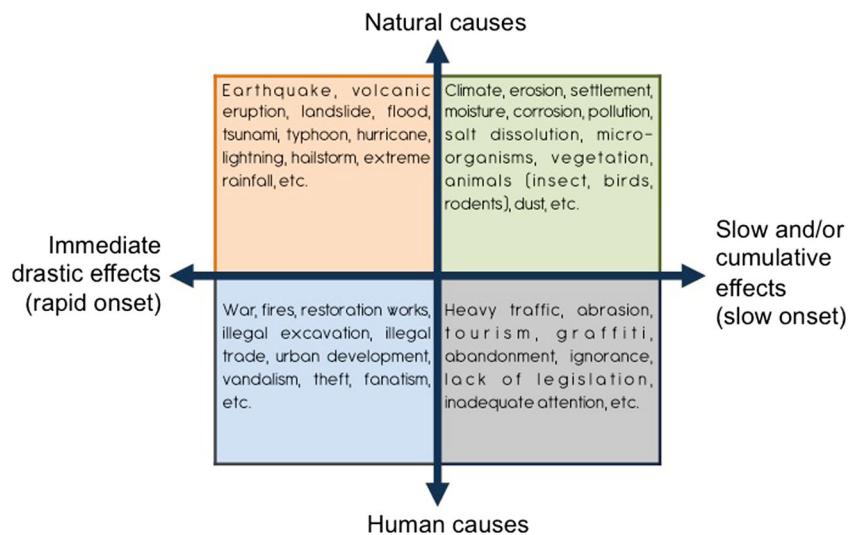
Fig. 2 Threats facing Cultural Heritage sites in general (ICCROM 2006, modified)

Potential threats affecting cultural heritage sites are outlined in Fig. 2.

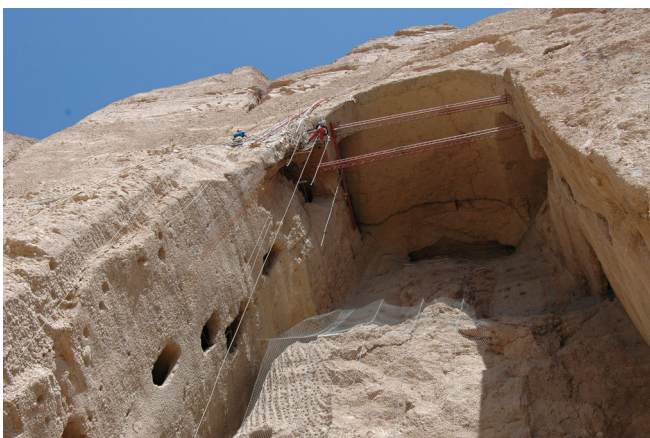
**Fig. 5** Climbers at work on stabilization of the left side of the Eastern Giant Buddha niche

vicinity of the niches, which have deteriorated from both the explosions and natural processes. The emergency measures were also aimed at allowing archaeologists to catalog and remove the Buddhas’ rock remains safely (Fig. 5).

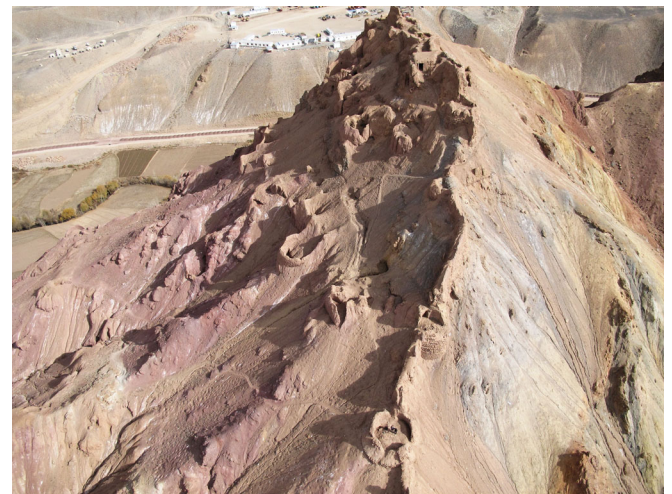
**Fig. 6** The upper part of the Shar-e-Zohak red fortress. Damage to buildings and archaeological remains is quite evident. Aerial photo from drone (Courtesy of Iconem)

The remains of the Shahr-e Zohak fortress are located on a steep hill at the confluence of the Kalu and the Bamiyan rivers, about 15 km east of the city of Bamiyan (Central Afghanistan). The site is thought to have been built during the Buddhist period (sixth–seventh century A.D.), even though the fortification is attributed to the Islamic period. Its position provided both excellent natural defenses and control of the valleys, which are communication routes (Fig. 6).

The fortress walls are mainly made of mud bricks, made from the local clayey red mud, and placed on top of gravelly foundations. Due to prolonged exposure to weathering, a lack of conservation measures, and damage during periods of war, many constructions have collapsed or are prone to collapse. Wall deterioration is coupled with the lack of an adequate drainage system to collect runoff. Ramparts located on the steep hill slopes are severely affected by gully erosion and siphoning, with depressions

infilled by eroded and weathered building material. The access path is locally eroded or buried by debris cones. The western margin of the plateau is rapidly retreating due to collapses, while the citadel is in danger due to diffuse or gully erosional processes on all of its sides.

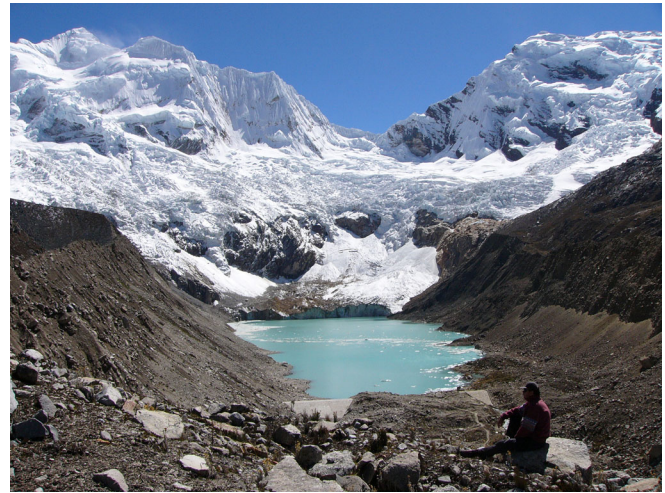
**Fig. 7** Lake Palcacocha in the Huascarán National Park, where glacial lake outburst floods recently have been studied

The Cordillera Blanca, as the most widely glaciated mountain range in the tropics worldwide, is a significant natural laboratory for understanding relations between ongoing processes, responses, and threats (Fig. 7). Older landforms document morphological processes in the Quaternary. One locality inside the national park where the direct influence of natural hazards on cultural heritage
