Geomorphologic impacts of the glacial lake outburst flood from Lake No. 513 (Peru)

Abstract This article deals with the 2010 glacial lake outburst flood (GLOF) which happened in the Chucchún Valley in the Cordillera Blanca (Peru). The volume of the ice and rock fall from Mt. Hualcán was estimated to be about 500,000 m³ and the detachment zone was identified between 5,450 and 5,600 m a.s.l. Basic landforms and processes (e.g. stream erosion, accumulation) were characterized by field investigation (2010 and 2011) as well as the rate of deglaciation using remotely sensed data (1948, 1962, 1970 and 2010). Two relatively independent parts of the Chucchún Valley were identified from the point of view of sediment flux: uppermost part of the catchment (4,192–3,575 m a.s.l.), where even fine-grained sediments were laid down, and the lower reaches up to the confluence (3,191–2,640 m a.s.l.), where valley bottom sediments were mobilised by the increased discharge. The comparison of field data and potential for erosion or sedimentation derived from the HEC-RAS model mostly showed conformity and discrepancy occurred in the valley segments where an extreme discharge during the 2010 GLOF laid do

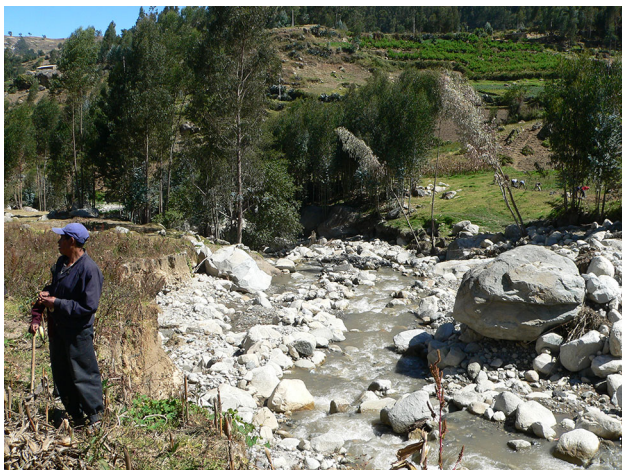
Fig. 2 An example of lateral erosion where part of the field was washed out. The largest block was only transported for a limited distance

The alarming reports about missing people published e.g. by www.larepublica.pe or www.peruviantimes.pe later proved to be false. The whole disaster claimed no fatalities; nevertheless, some houses, roads, bridges and an important water treatment facility were destroyed. The rather low extent of damage is due to the fact that the valley is not densely populated and some villages were left out of the reach of the debris flow. It was a considerable event due to the large amount of material transported down the valley; lateral erosion was documented inside the valley and the processes occurred very quickly. As an example, we could mention the case of one farmer, who lost part of his field together with his cattle (!)—see also Fig. 2.

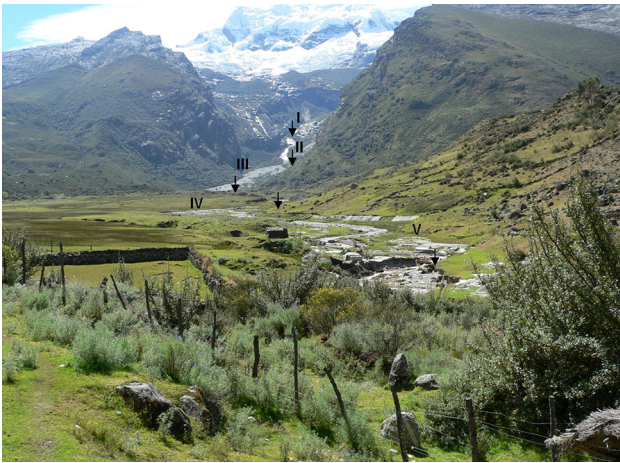
Fig. 5 The Pampa Shonquil is the location of a former glacial lake now filled by sediments. Fine-grained sediments from the 2010 GLOF were laid down here (segment V) while larger boulders reached “only” the mouth of the glacial valley (segment III)

An accumulation of boulders evolved at the beginning of the third segment (III) where the gradient of the Chucchún River sharply decreases from 20° to 6° (see Table 2; Fig. 5). The “lowering” of the gradient is important for the presence of boulder accumulations. The second important factor is that this river section follows after a part with high stream power (and sediment inputs). Conditions for the

The next segment IV represents an alluvial plain of an old lake behind Younger Dryas moraine (Giraldéz et al. 2014) filled by fine-grained sediments (Fig. 5). Lateral erosion has been underway in recent times leading to the creation of meanders.

The following section V is distinguished by the lowest stream gradient (Table 2; Fig. 5) together with the alluvial fan just before the confluence with the Santa River and the segment IV. Only fine-grained sediments were left behind here after the 2010 GLOFs, which also filled and blocked the drinking water supply intake facility. This area (known locally as Pampa Shonquil) is in fact the local base level for the erosion which takes place in the uppermost part of the catchment. Both types of sediment (boulder and fine-grained) are trapped in the territory of segments 3–5. Only the water itself and the sediments carried in suspension continue to the central part of the Chucchún River valley where transported material is entrained by both deepward and lateral erosion.

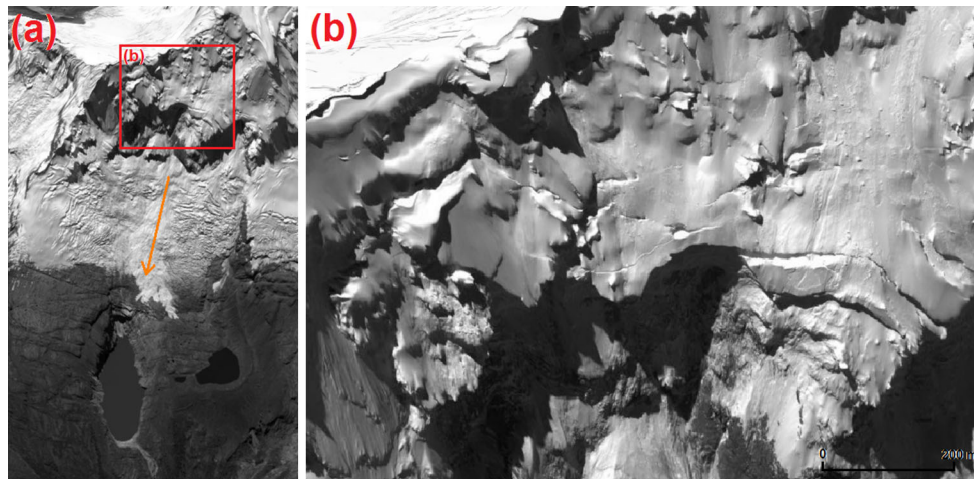
Fig. 6 Satellite image of the surroundings of Lake No. 513 (source: Google Earth Digital Globe 2013). **a** shows a view of Mt. Hualcán and lakes No. 513 and Cochca from the SW in May 2011. The *orange arrow* highlights the ice avalanche paths (*lighter colour*). **b** Detailed

view of the western slopes of the Hualcán massif at an altitude of between 5,250 and 5,750 m a.s.l. Three blocks of the overhanging part of the glacier are clearly visible in centre of this picture

period of time (Figs. 6b, 7). These blocks are between 200 and 300 m wide and 70–130 m high, and are situated at an altitude of about 5,500 m a.s.l. The thickness of blocks is not exactly known from the remotely sensed photographs, but we estimate the thickness to be in the order of tens of metres; thus, the volume of each block is estimated to be about 200,000– 800,000 m³ (the volume of avalanche
