**INSTITUTE OF GEOGRAPHY
ROMANIAN ACADEMY**

LAND USE/LAND COVER CHANGES ALONG THE ROMANIAN DANUBE VALLEY IN THE POSTCOMMUNIST PERIOD

Dan BĂLTEANU, Monica DUMITRAȘCU, Elena-Ana POPOVICI

Köln - 2012

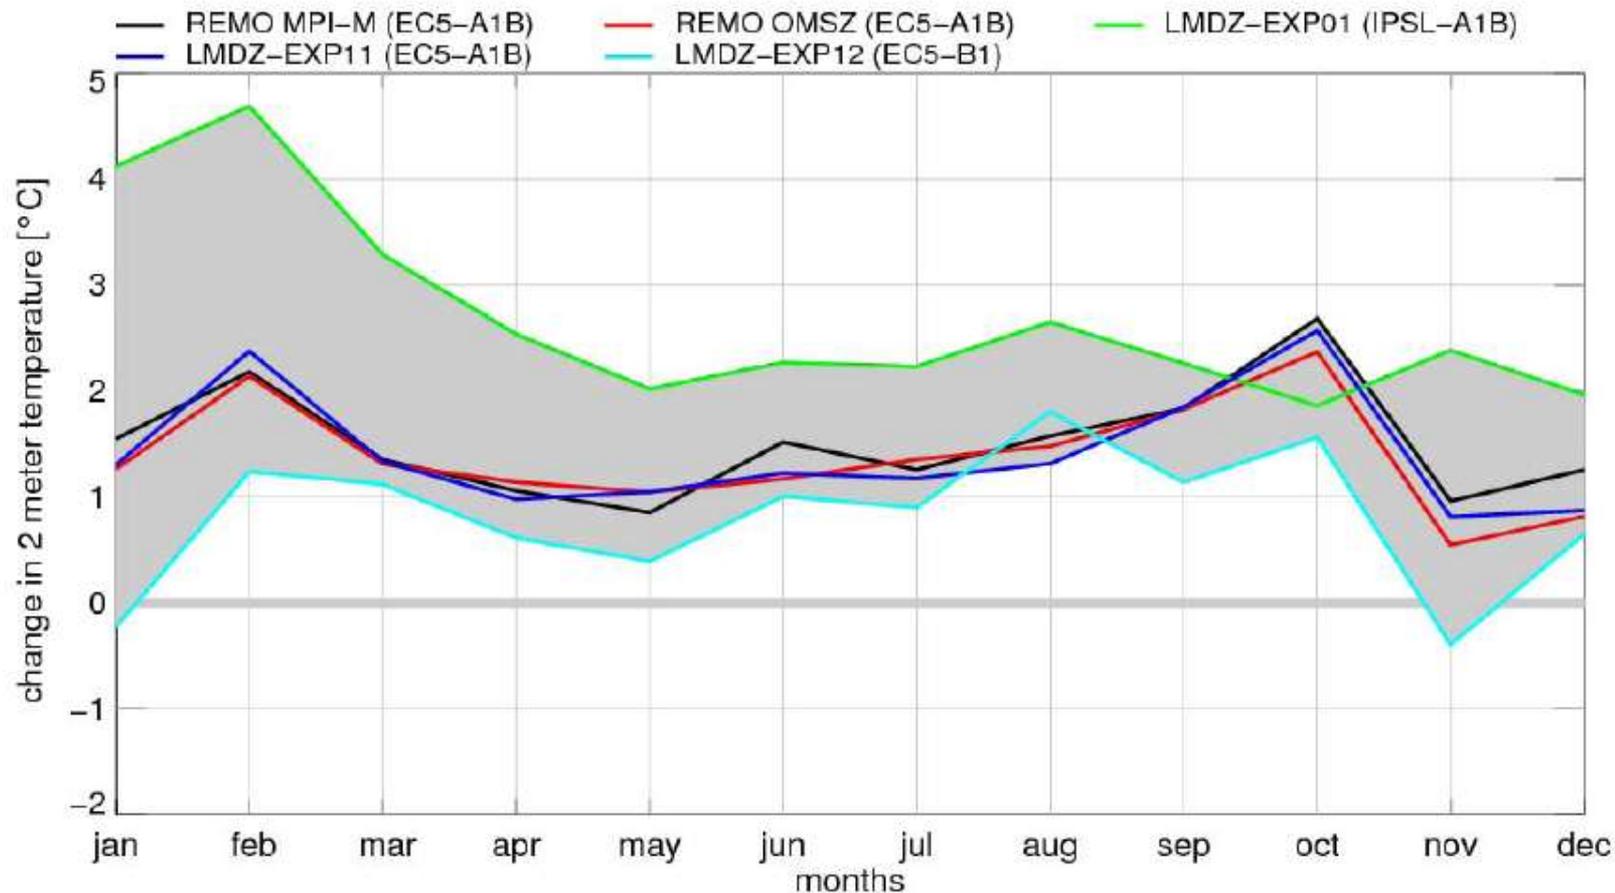
Climate Change Signal in Romania in Mean Monthly Temperature (2021-2050 vs. 1961-1990)

- Estimated increase of annual mean temperature: $\sim +2^{\circ}\text{C}$.
- Range of increasing rates: $\sim +1^{\circ}\text{C}$ to $+4^{\circ}\text{C}$.
- **General trend of climate warming: all seasons** (less than $+1^{\circ}\text{C}$).
- **Transition toward milder winters: $+2.8^{\circ}\text{C}$.**

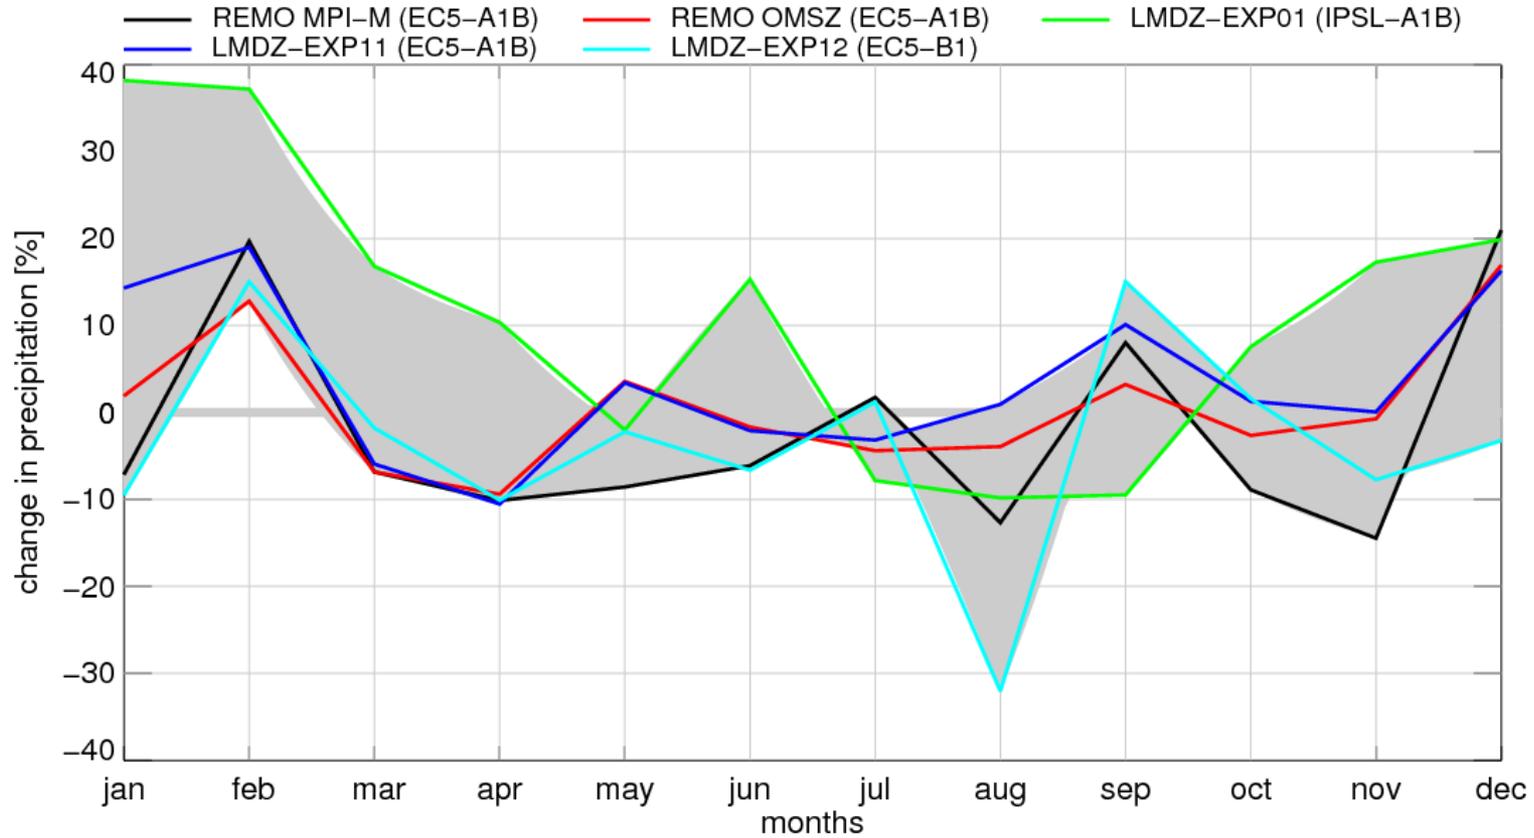
Climate Change Signal in Romania in Precipitation (2021-2050 vs. 1961-1990)

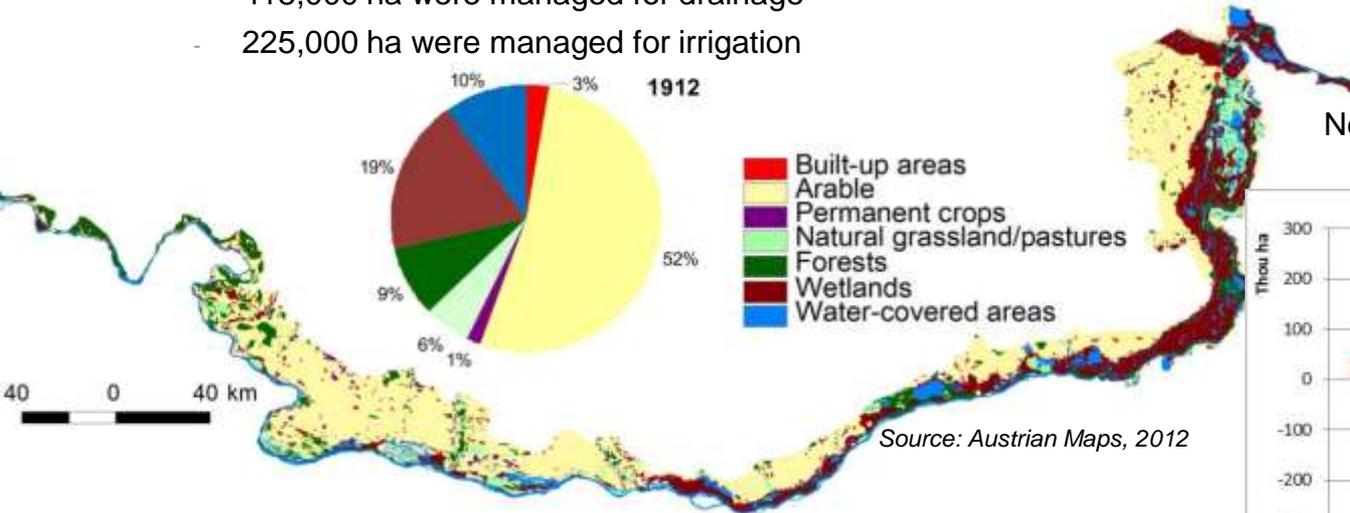
Net changes in land use categories, 1912 - 1990

- ▶ The Danube Floodplain covers 573,000 ha
- **1960-1970 – 431,760** (75% of the overall area) were dammed:
 - 1,158 km of dams,
 - 418,000 ha were managed for drainage
 - 225,000 ha were managed for irrigation

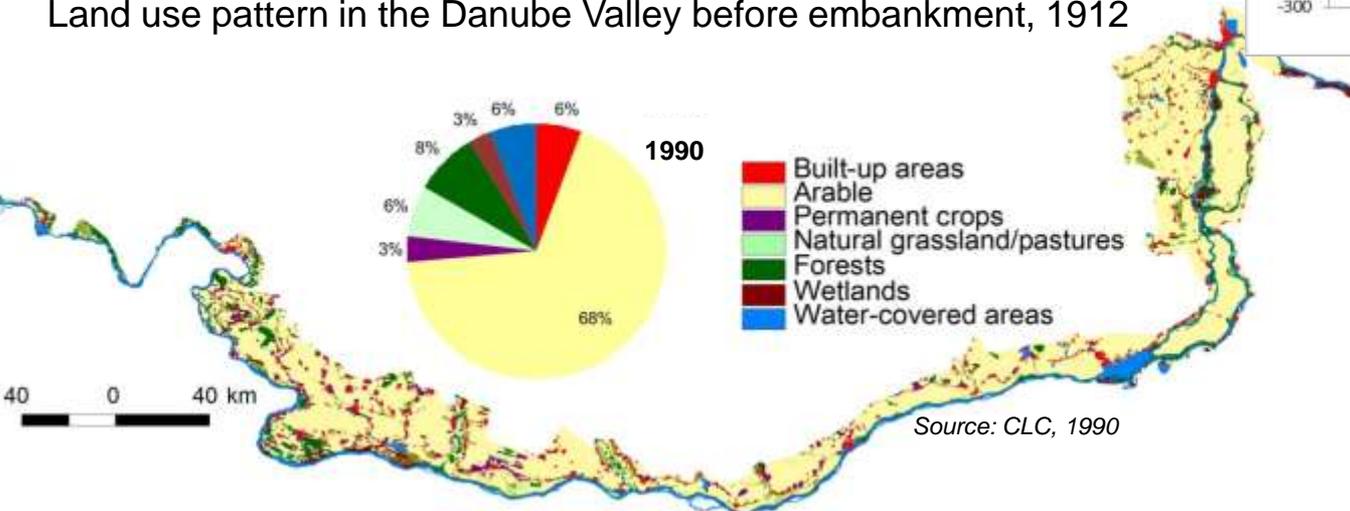
Land use pattern in the Danube Valley after embankment, 1990

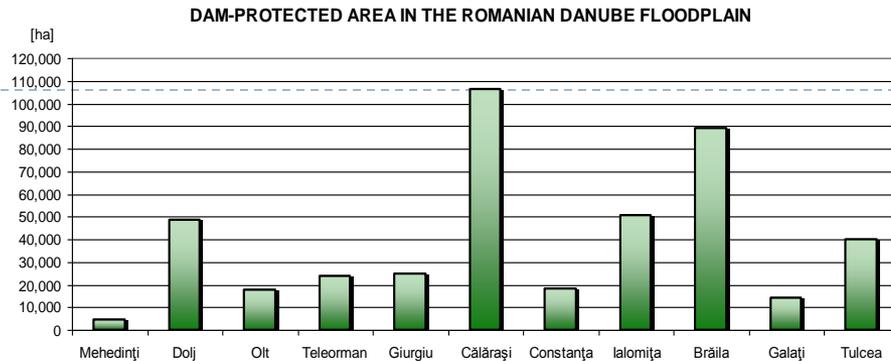
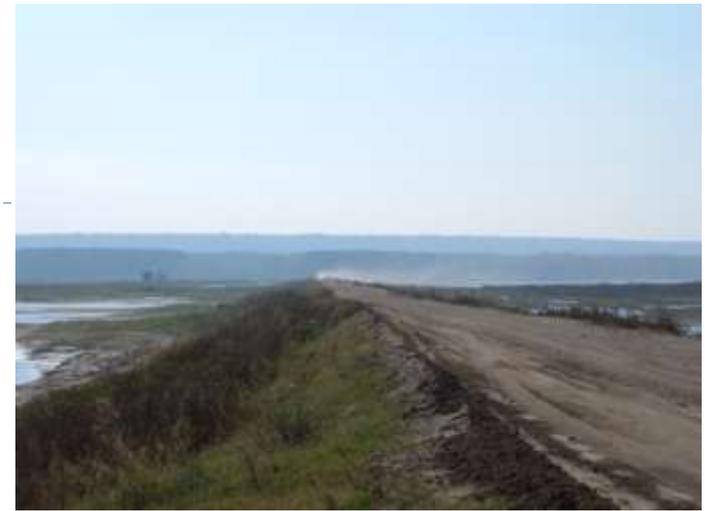
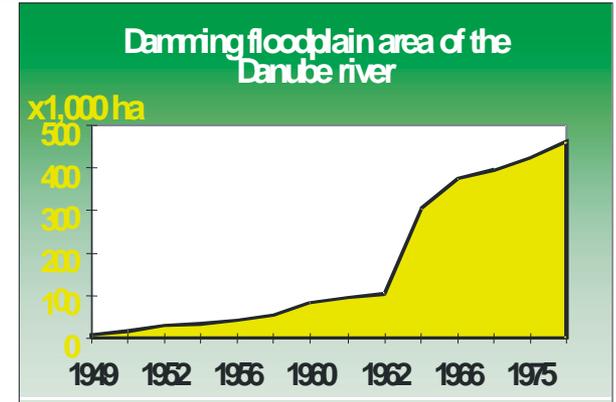
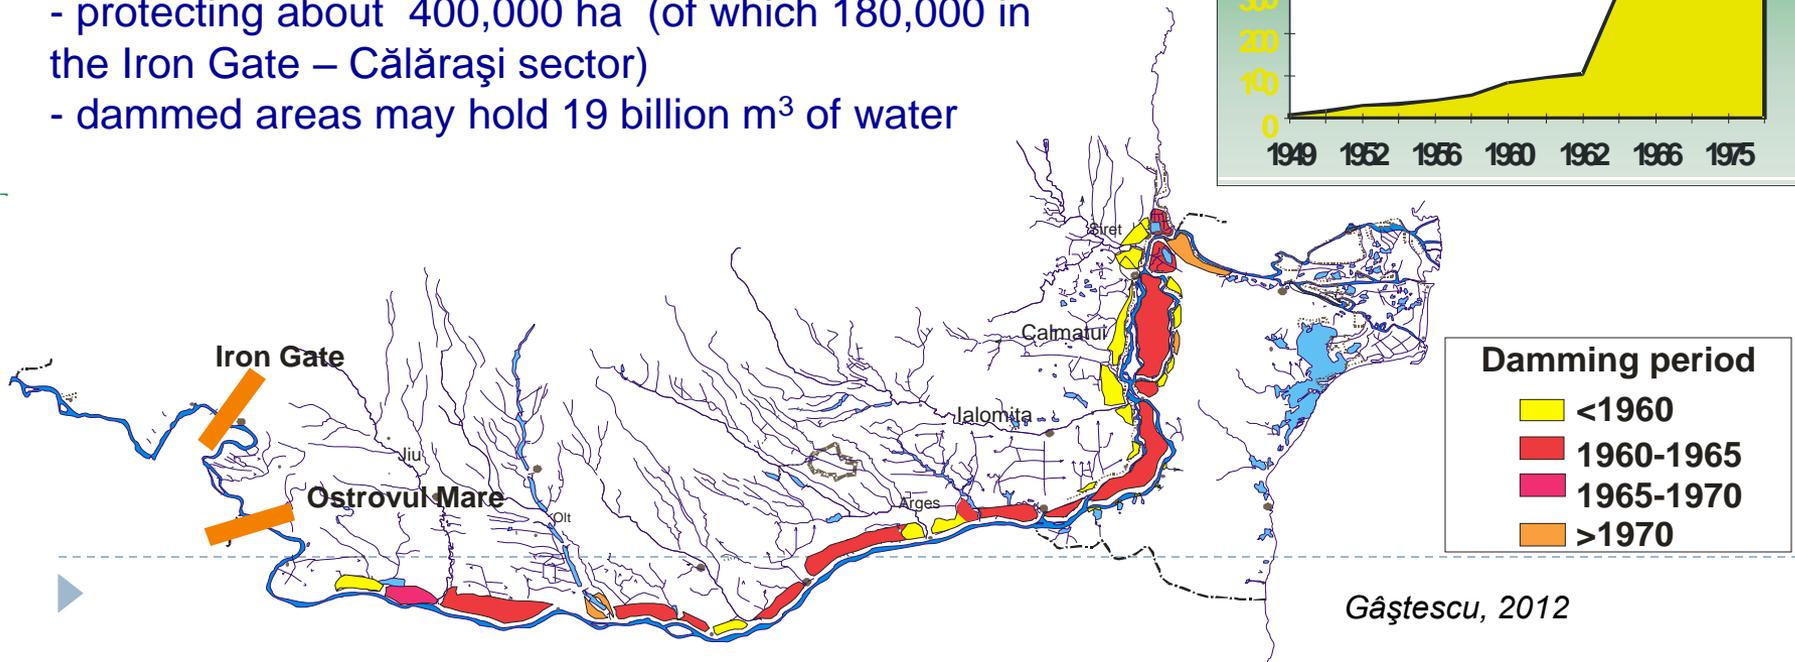
Danube Floodplain management works

Dams totalling 3,520 km of which 1,100 km in Romania

1,100 km of dams :

- protecting about 400,000 ha (of which 180,000 in the Iron Gate – Călărași sector)
- dammed areas may hold 19 billion m³ of water

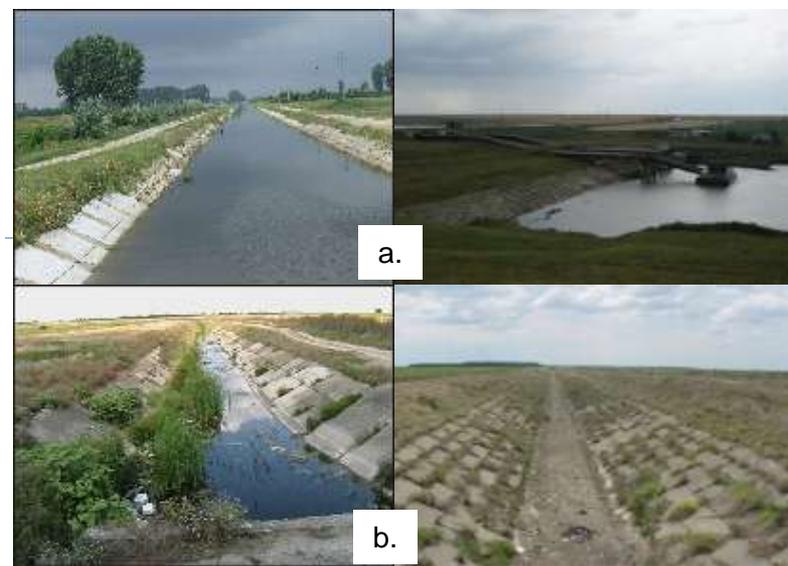
- Over 2,677 thou ha of agricultural lands are managed with irrigation systems, but most of them were destroyed after 1990, or left in an advanced state of degradation.

Irrigation systems.
Functional (a) and abandoned (b)

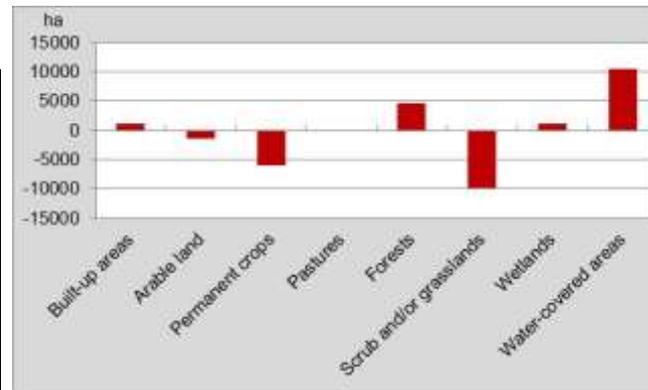
Area in 1990	Area in 2006	Changes 1990_2006
Built-up areas	85,963	87,080	1,117
Arable land	1,069,641	1,068,130	-1,511
Permanent crops	58,841	52,898	-5,943
Pastures	67,140	67,061	-78
Forests	120,982	125,659	4,677
Scrub and/or grasslands	42,990	33,166	-9,825
Wetlands	42,213	43,399	1,186
Water-covered areas	80,205	90,713	10,508

Net changes in land use categories over the 1990-2006 period

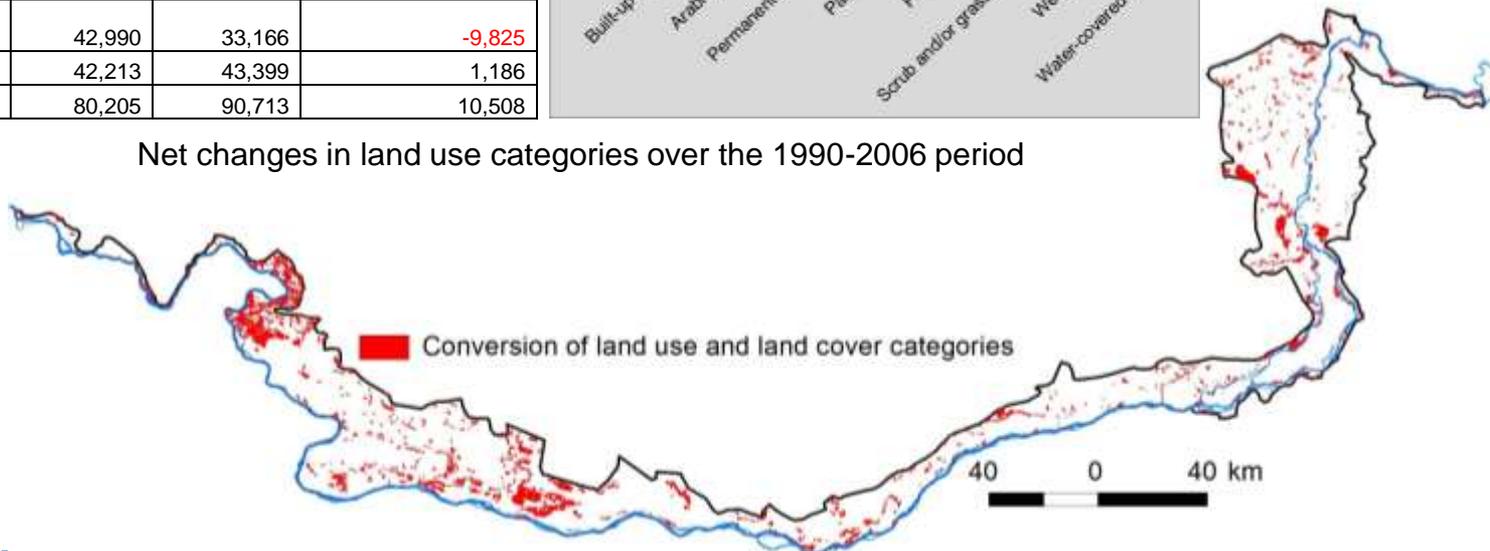
Land use changes over the 1990-2006 period

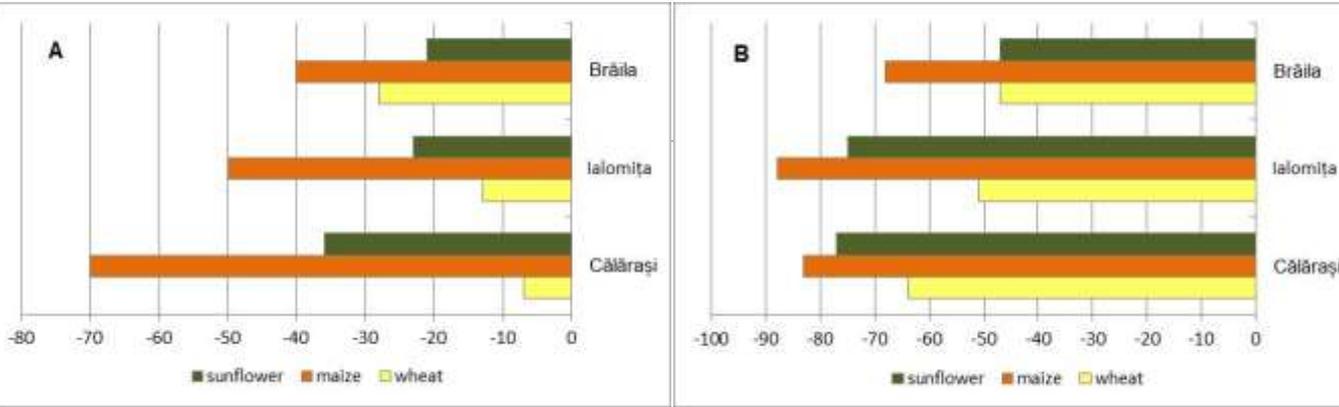
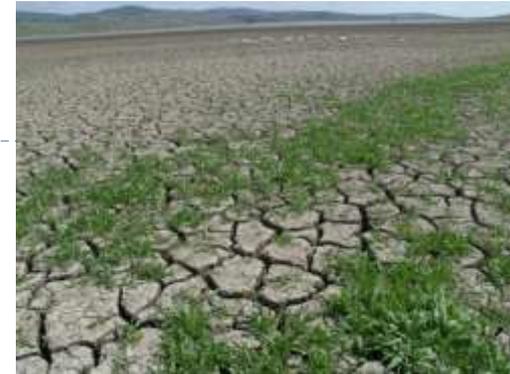
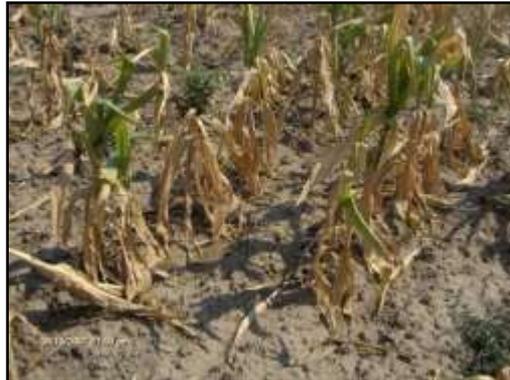
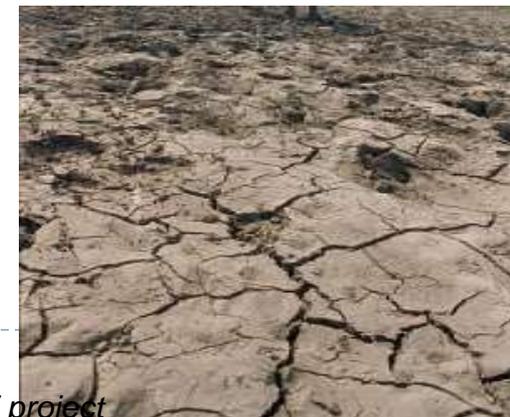
Impact of the drought on average yield for main crops (% reduction) for 2000 relative to 1999 (A) and 2007 relative to 2006 (B) in Bărăgan Plain

- in particularly droughty years of 2000 and 2007, average yields/ha for grain cereals were significantly depleted (under 1,000 kg/ha)

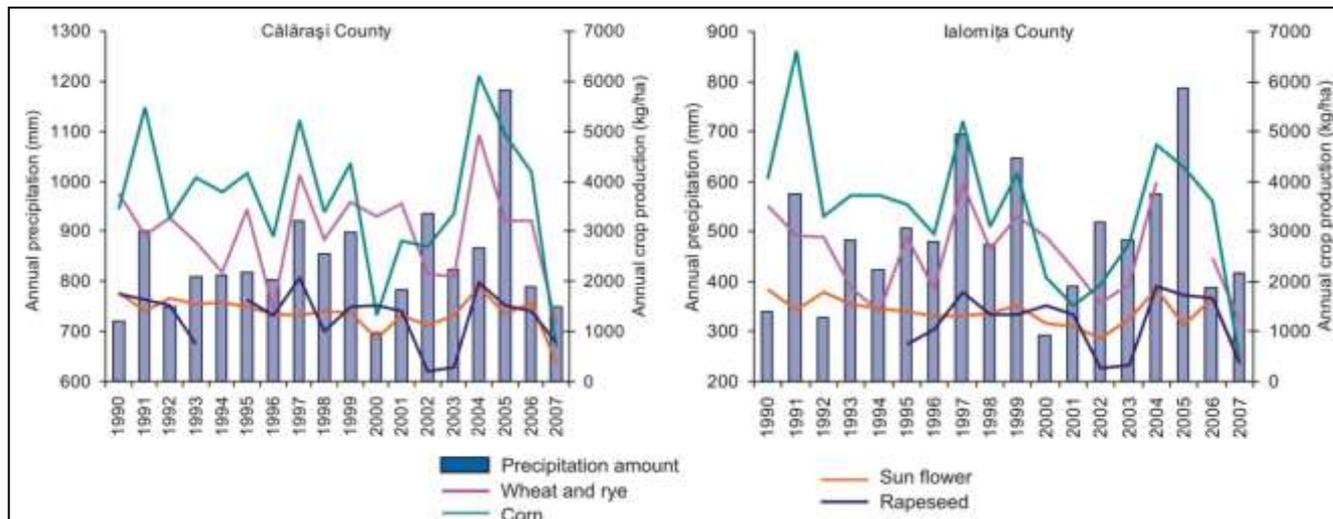
Correlation between the average yields of the main crops and annual precipitation amounts (1990-2007)

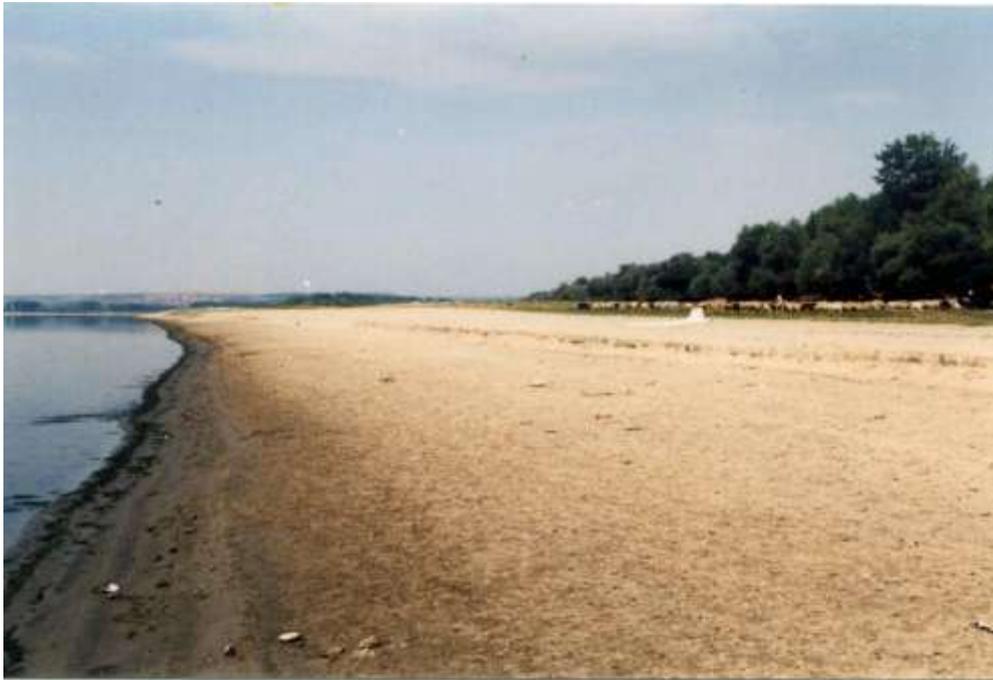
Zimnicea, 30 august 2003

The lowest Danube level in the last 160 years

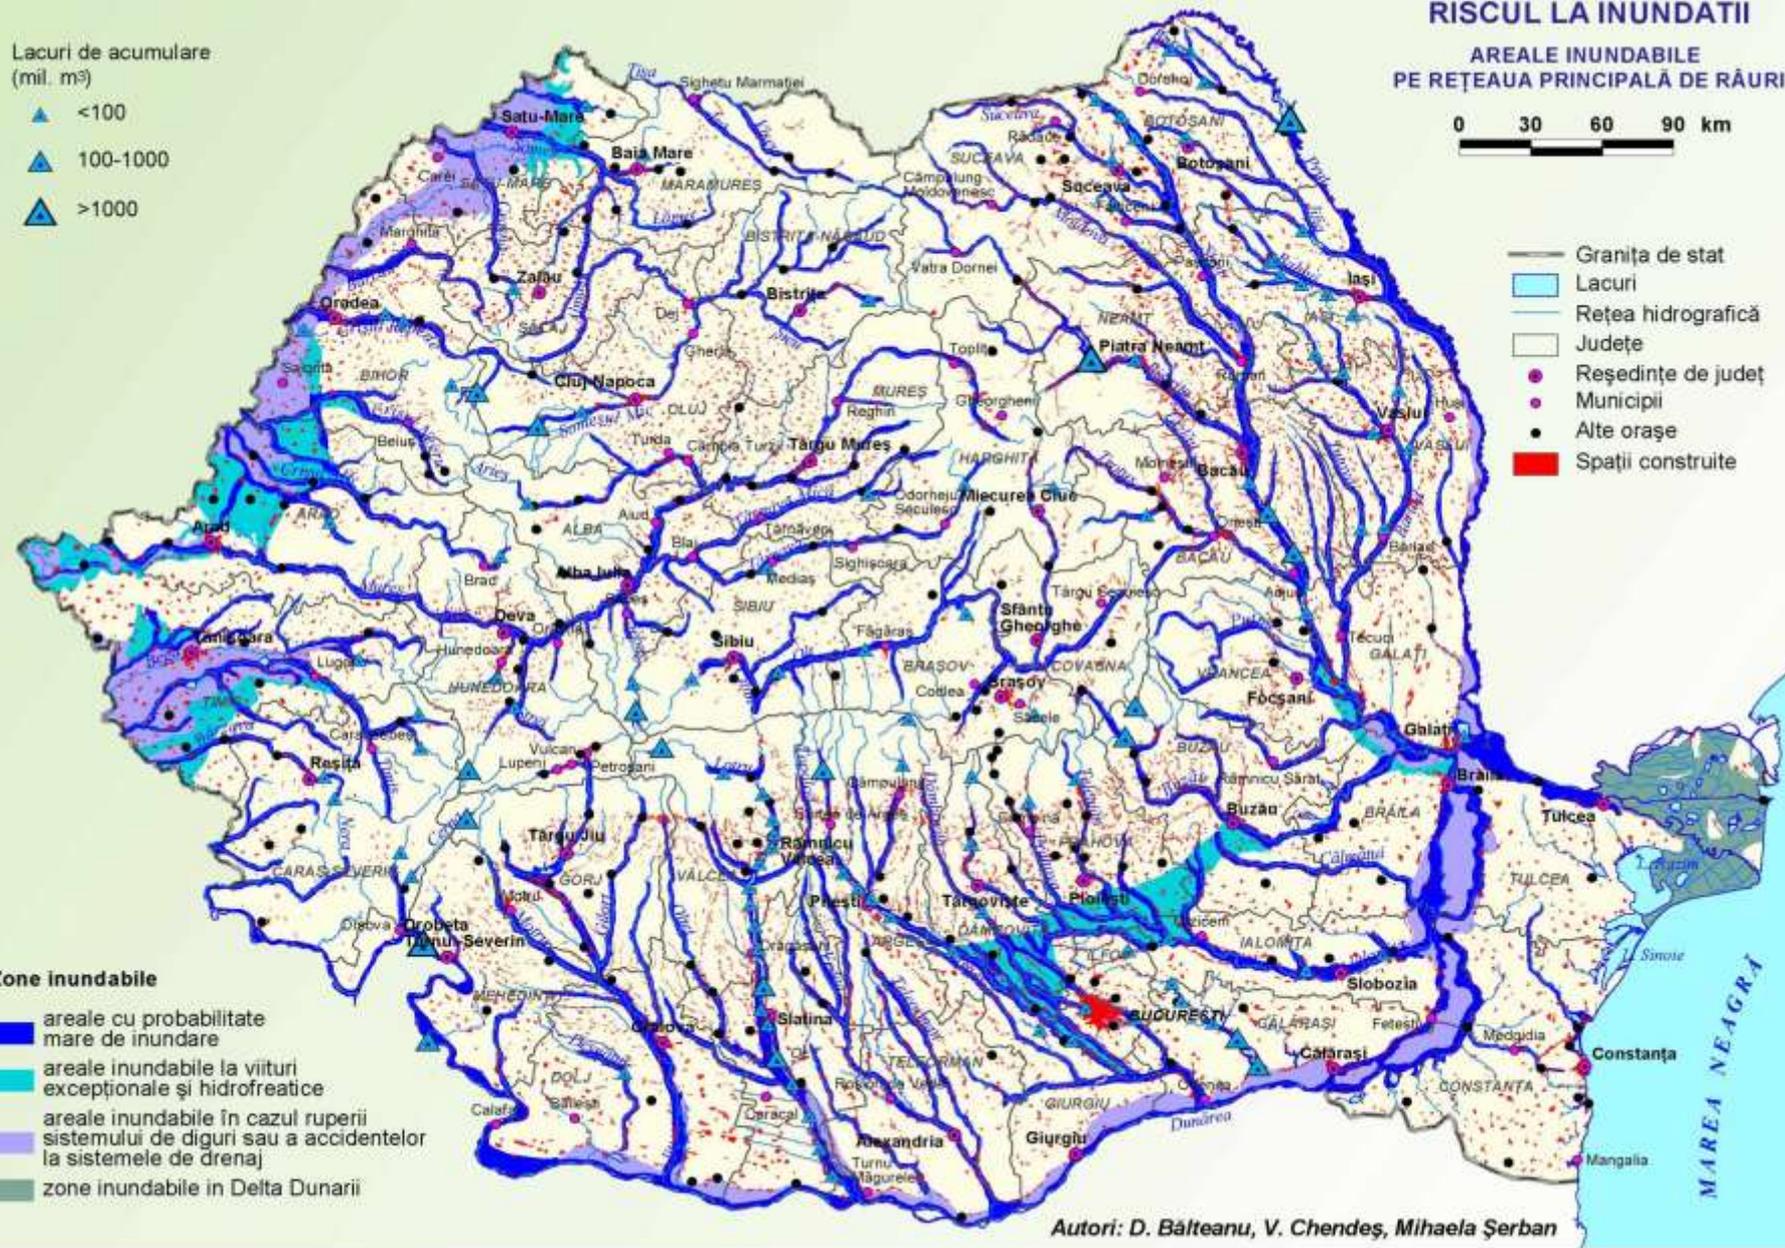
RISCU LA INUNDATII

AREALE INUNDABILE PE REȚEAUA PRINCIPALĂ DE RĂURI

Zone inundabile

- areale cu probabilitate mare de inundare
- areale inundabile la viituri excepționale și hidrofreatice
- areale inundabile în cazul ruperii sistemului de diguri sau a accidentelor la sistemele de drenaj
- zone inundabile în Delta Dunării

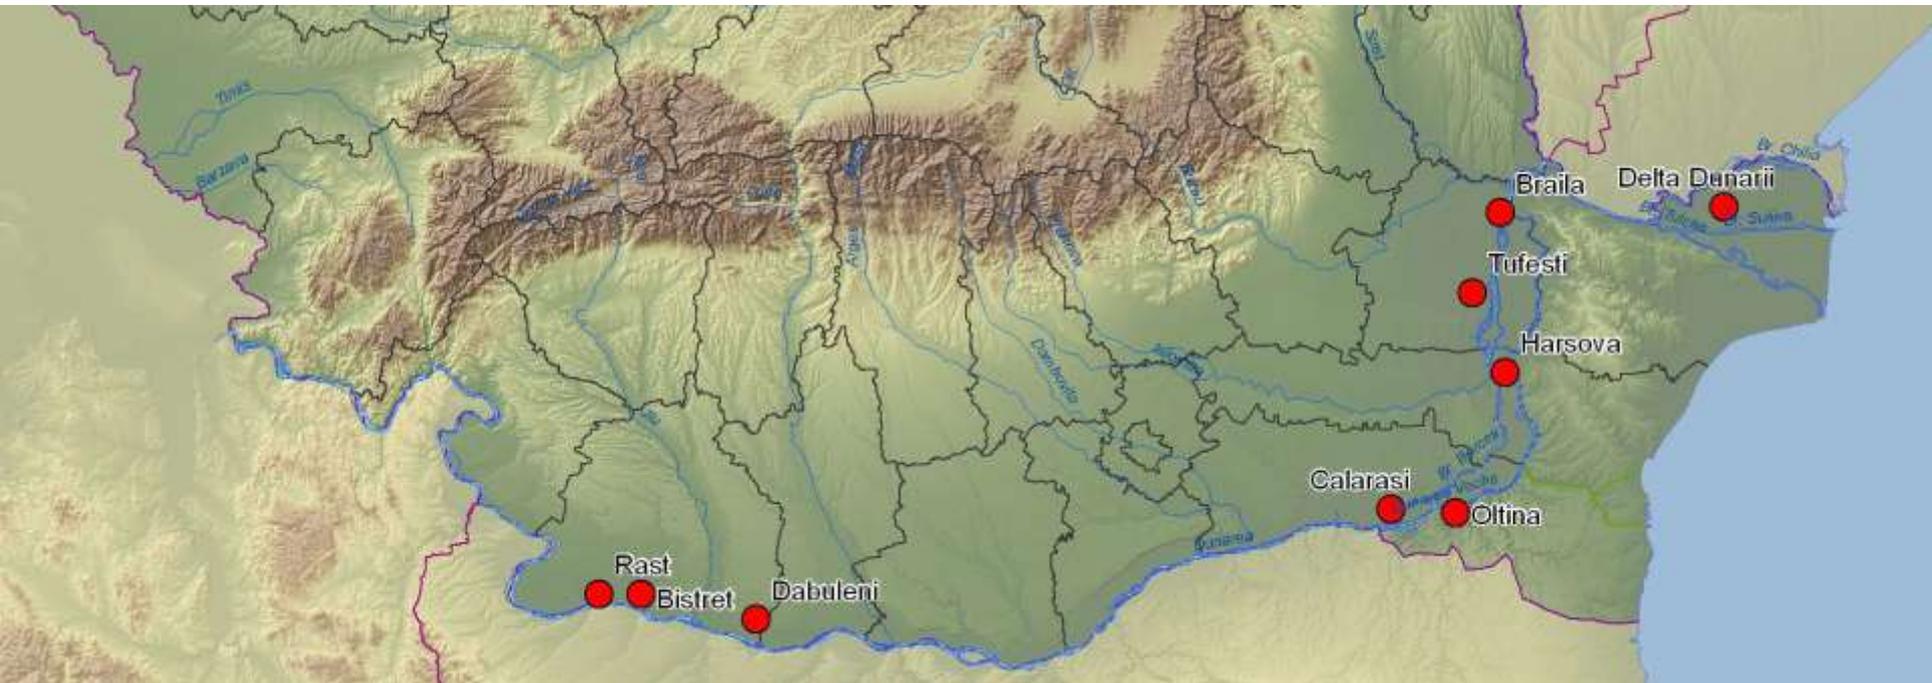
Major hot-spots of dam breaking (April – May 2006 flood)

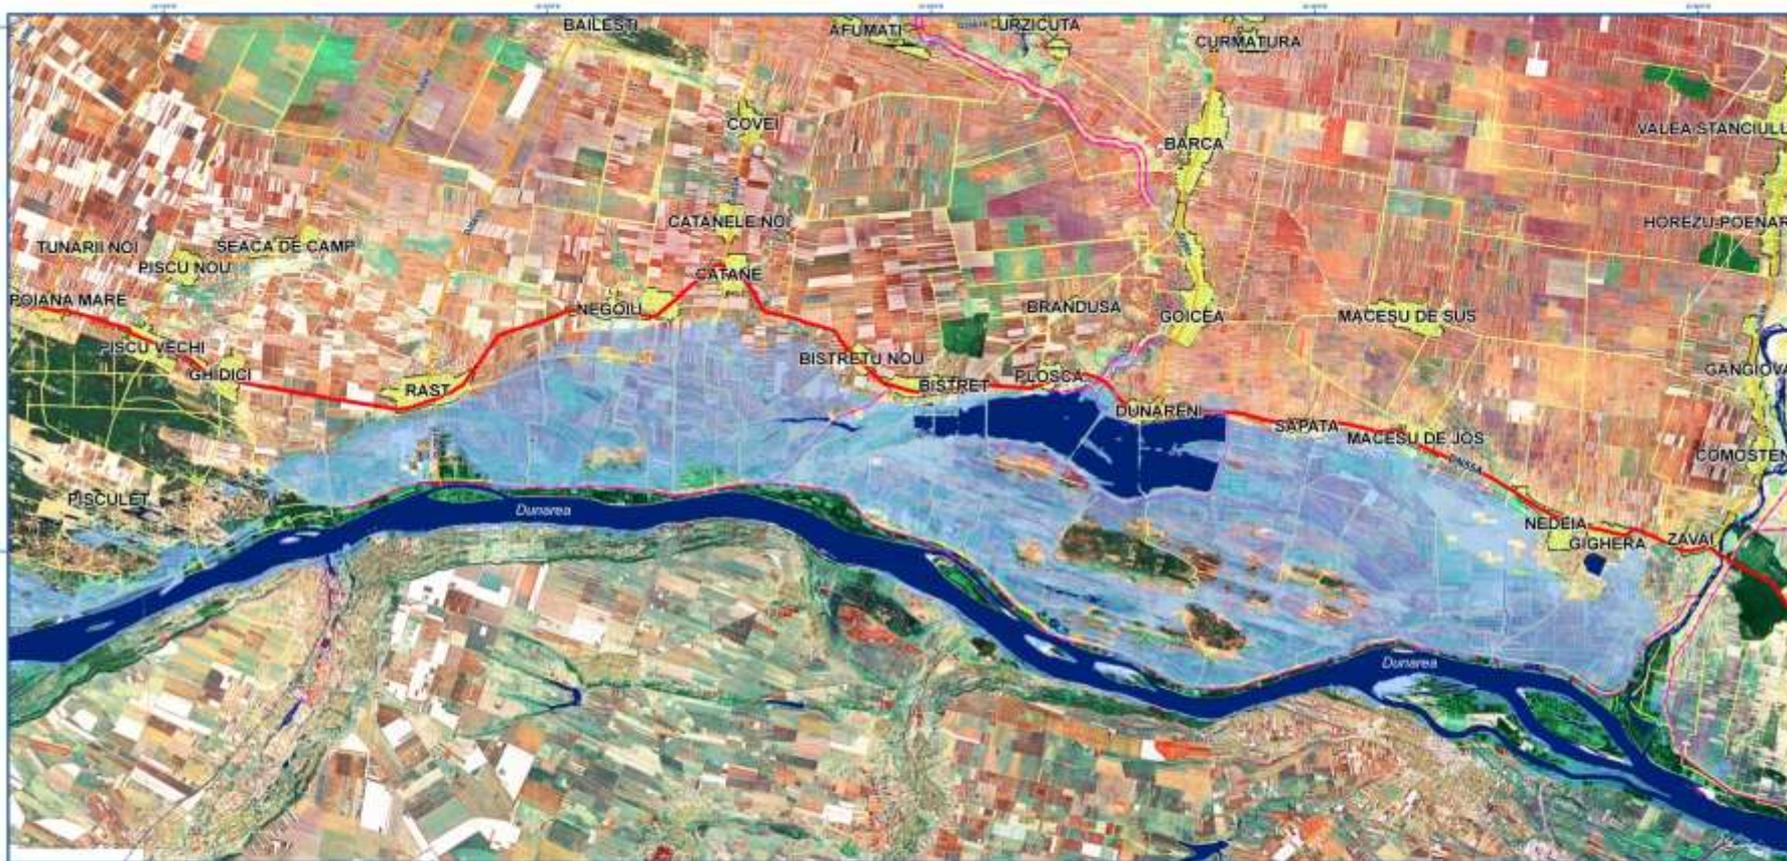
Zonele inundate din Lunca Dunării: Sector Ghidici - Rast - Bistret - Macesu de Jos. 01.05.2006 ora 12:40

Urmasa a debitului istoric inmaginat pe Dunare in Aprilie 2006, digul ca proteja terenurile agricole din sudul judetului Dolj a cedat in data de 14.04.2006 pe teritoriul comunei Catane.

Suprafetele inundate au fost obtinute prin prelucrarea imaginii MODIS/TERRA din data de 01.05.2006 (rezolutie spatiala de 250 metri).

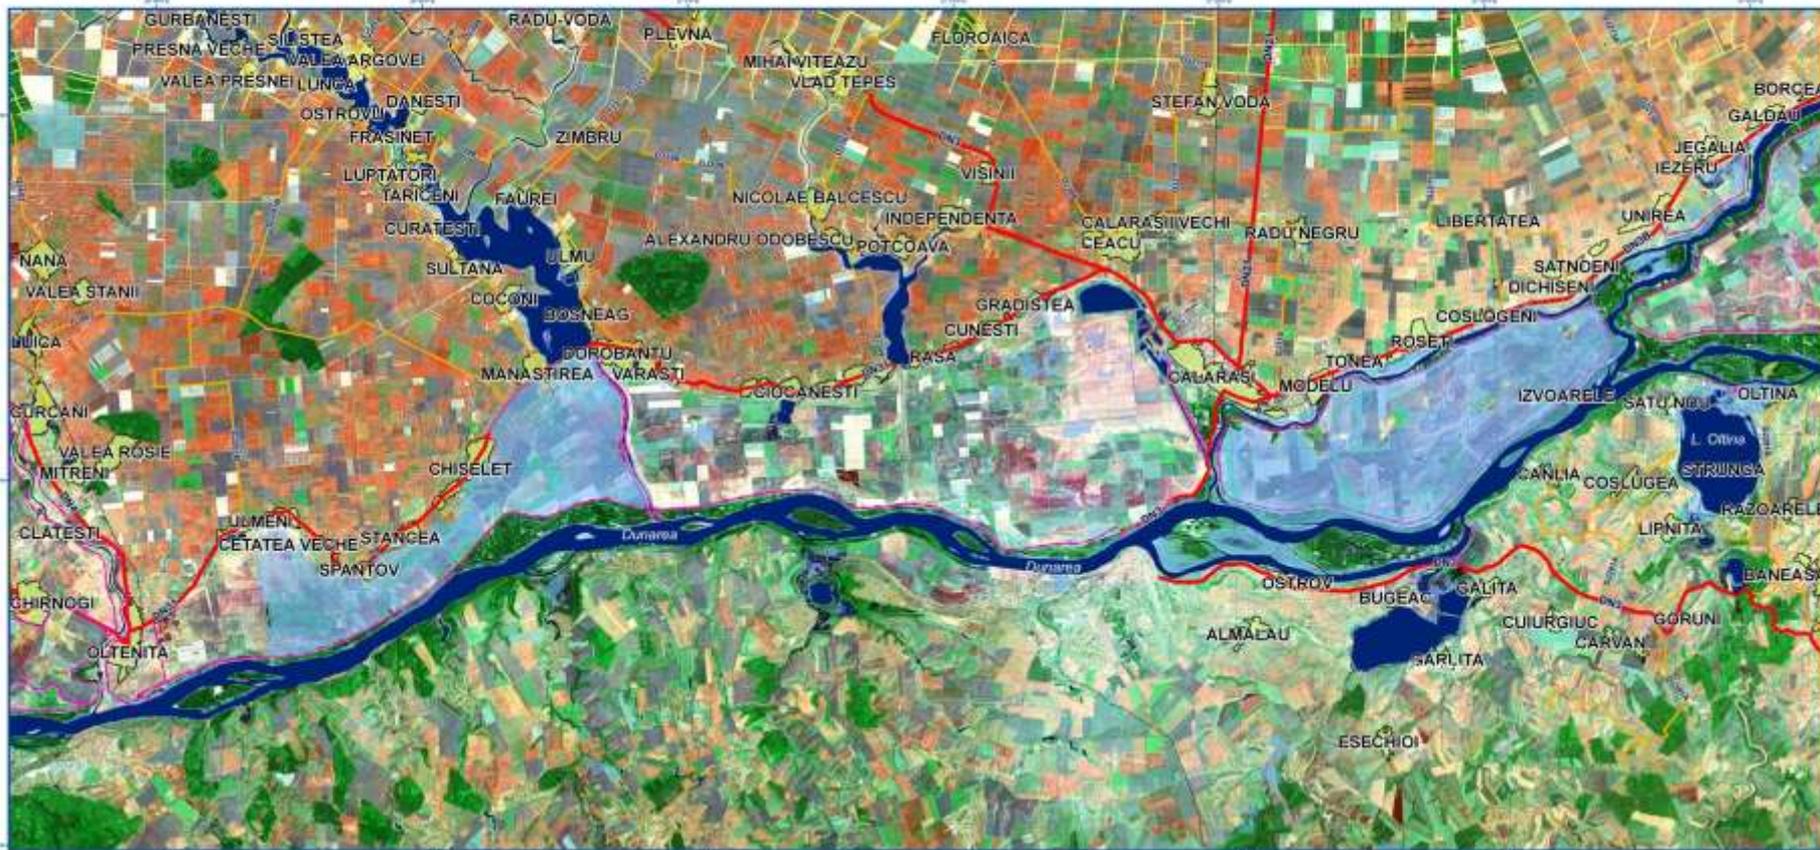
Zonele inundate din Lunca Dunarii: Sector Oltenita - Calarasi. 14.05.2006 ora 11:10

Urmasa a debitului istoric inegalizat pe Dunarea in Aprilie 2006, digul ce protejeaza terenurile agricole din sudul judetului Calarasi a cedat in data de 24.04.2006 pe teritoriul comunei Spantov. Apoi revarsate s-au apropiat pericolos de mult de orasul Oltenita. Anterior, in data de 23.04.2006 s-a produs o breasa in digul ce separa bratul Dunarii de lacul Oltina. Datorita cresterii nivelului in lac a fost amenajata localitatea Oltina.

Suprafata inundata au fost obtinute prin prelucrarea imaginii MODIS/TERRA din data de 14.05.2006 (rezolutie spatiala de 250 metri).
