Landslides (2011) 8:309–320
 DOI 10.1007/s10346-010-0249-1
 Received: 6 December 2009
 Accepted: 2 December 2010
 Published online: 11 January 2011
 © Springer-Verlag 2011

Jan Klimeš · Vít Vilímek

A catastrophic landslide near Rampac Grande in the Cordillera Negra, northern Peru

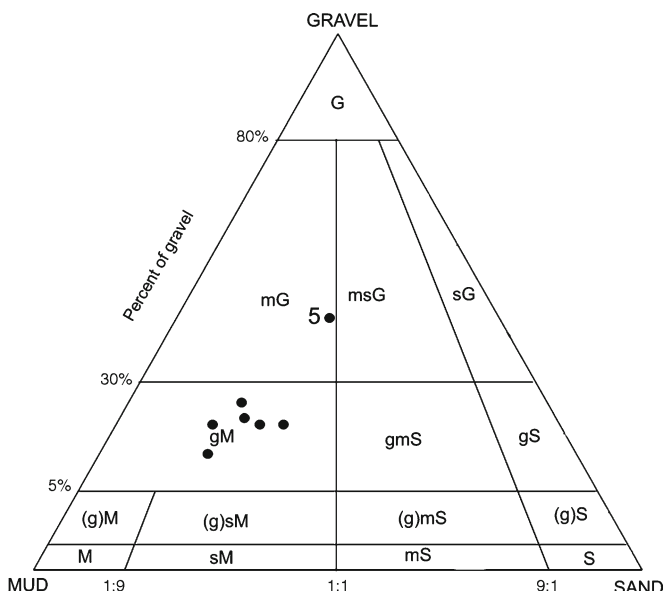
The landslide material comprises a mixture of highly weathered argillite rocks and tuffs of various colors and mineral composition with a significant portion of secondary carbonates (Table 1). The samples contain a dominant component of clay particles with only a minor component of sand grains, and they are classified as fine gravelly very coarse slit sediments (Fig. 6). It should be noted that sample 5 has very distinct granulometric characteristics as it comprises more than 50% sand (classified as fine, gravelly, very coarse slit sediments). Mineralogical analysis shows significant differences in the composition of the samples (Table 1). This particularly relates to the smectite and quartz contents. For example, the largest proportion of smectite was found in sample nos. 5 and 6 (29% and 10%, respectively) while some traces were also found in sample nos. 1, 7, and 8 (4% each). Surprisingly, sample 4, taken just 3 m from sample 5, does not record any smectite minerals. However, the colors of these two samples are markedly different—sample 5 is ochre while sample 4 is red. This suggests that there was considerable mixing of materials from different source areas within the landslide.

Fig. 6 Granulometric analysis of the samples (5 indicates sample no. 5)

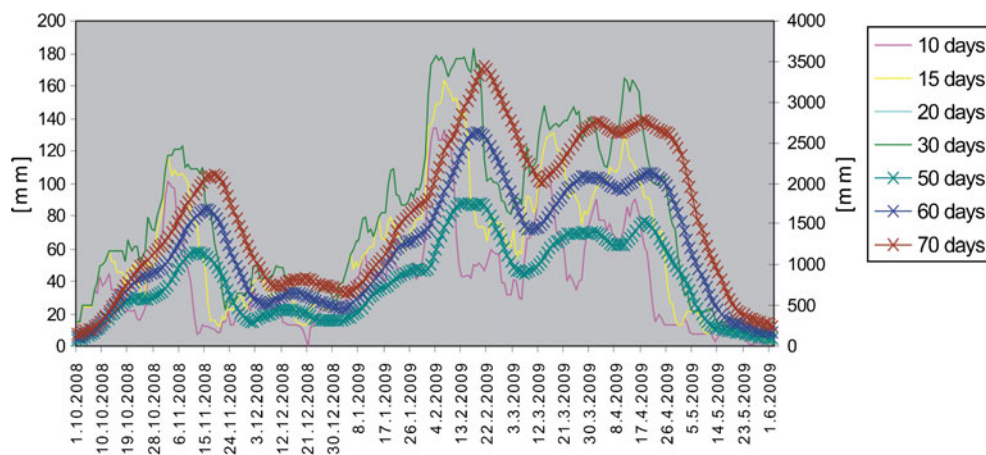
70 days moving averages largely failed to provide any explanation for the landslide. In every case, the landslide occurred during an overall decrease in mean precipitation, which showed a distinct peak 7–14 days before the event. The 30 days moving average curve shows minor peak for 24.–25.4. In addition, much larger values of the moving average occurred in February 2009 when compared with the data for April 2009 (Fig. 14). However, the difference between the monthly potential evapotranspiration and monthly total precipitation was also calculated (Fig. 15). These data show a large precipitation surplus of 100 mm for March 2009 that changes to a precipitation deficit of 17 mm for April 2009. This implies that the landslide could have resulted from the accumulation of excess water during March 2009 if a lag of about 25 days between rainfall and landslide is assumed. Nevertheless, we cannot rule out the possibility that the landslide movement started during the peak precipitation in April and accelerated into the sudden event after several days (10–14) of preparatory phase. Unfortunately, no witnesses about possible movement initiation in the crown area are available.

Fig. 14 Ten, 15, 20, 30, 50, 60, and 70 days moving precipitation averages for the Huaráz meteorological station

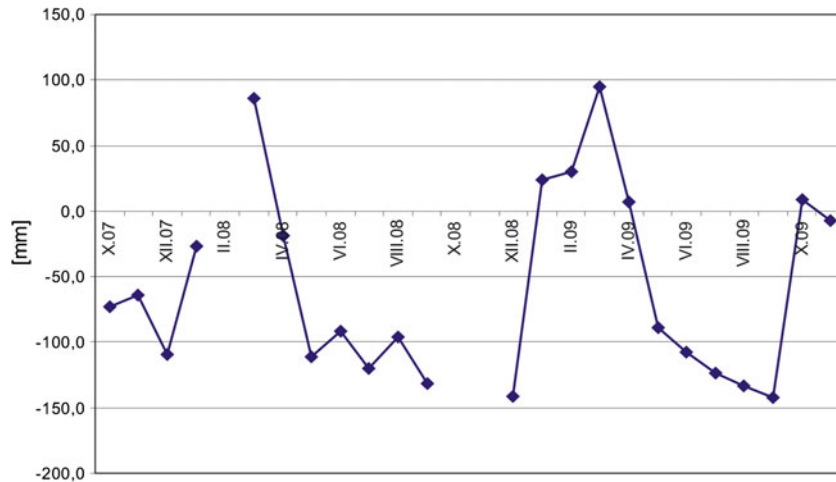
Fig. 15 The calculated difference between the total monthly potential evapotranspiration and the total monthly precipitation (data from SENAMHI)

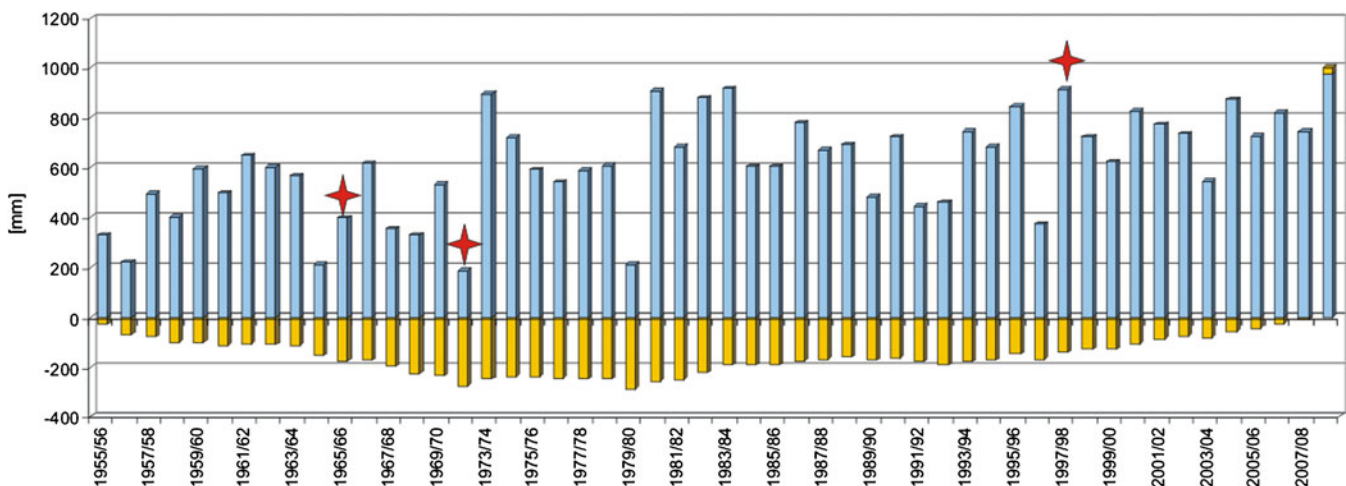
The changes in total precipitation during each rainy season (October–March) in relation to the long-term average have also been examined (Fig. 16). There is a clear increase in the total amount of rainy season rainfall from 1982 to 1983. This is particularly pronounced from 1997 to 1998. The total amount of rainy season rainfall peaked at 975.6 mm in 2008–2009, the same year as the landslide. This is despite the fact that two strong El Niño events, characterized by enhanced precipitation, occurred during this time (Kane 2000). During the first event in 1982–1983, the rainy season precipitation total attained 880.8 mm whereas during the second event in 1997–1998, the rainy season precipitation total attained 912.9 mm. Moreover, the monthly rainfall of 229.6 mm recorded during March 2009 was the second highest monthly total recorded after March 2006 (252.6 mm). If the amount of precipitation is the major triggering factor for the studied landslide, its initiation relates more closely to longer-term trends rather than short intense rainfall events. Therefore, long-term soil saturation may be decisive in dictating the occurrence of landslides. The extreme rainy season of 2008–2009 is likely to have caused saturation and build-up of pore water pressure in the deeper parts of the slope, lowering its stability and resulting in the sliding and subsequent flow processes.

Fig. 16 The total precipitation for each rainy season (October–April) since 1956 (in blue) and the accumulative disparity between them and the long-term average (in yellow). Based on data recorded at Huaráz, the mean total precipitation during the rainy season is 556 mm for the period 1955–2009 (SENAMHI). Red stars mark rainy seasons with reported landslide occurrence (years of 1966, 1970, 1997)
