The 1916 catastrophic flood following the Bílá Desná dam failure: The role of historical data sources in the reconstruction of its geomorphologic and landscape effects

Pavel Raška^{a,*}, Adam Emmer^b

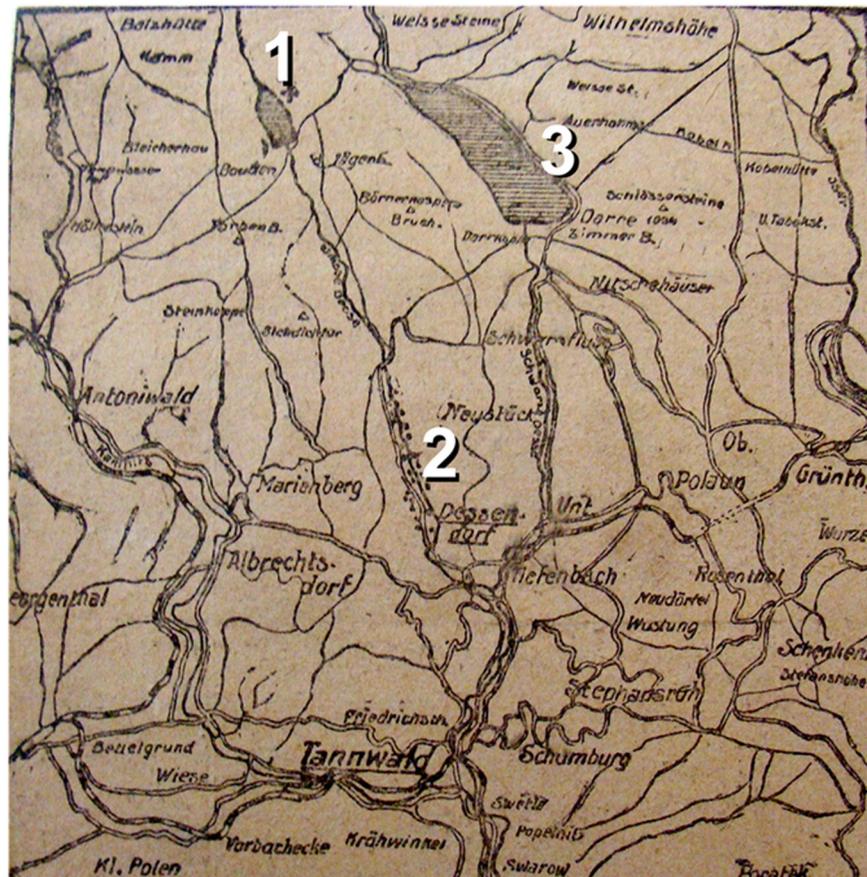
Fig. 2. Unique archival map showing the position of the Bílá Desná dam (1) in the short interval between its completion and failure. The village of Desná (Dessendorf) is represented by (2), and the Souš dam is represented by (3). The Bílá Desná reservoir was connected to the Souš reservoir by an underground tunnel. Source: Archive in the Jablonec nad Nisou.

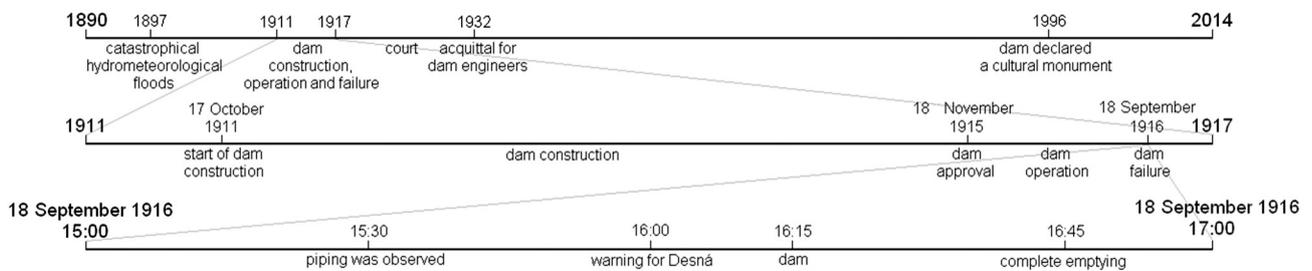
The Bílá Desná dam construction began in 1911 because of discussion concerning the construction of dams in the Jizerské Mts., which started after catastrophic hydrometeorological floods at the end of June 1897 and finished four years later with dam approval on 18 November 1915 (Fig. 3). The longevity of the dam was only 10 months, before the dam failed on 18 September 1916.

Fig. 3. Chain of events connected to the Desná dam failure (according to Smrček, 1917; Žák et al., 2006).

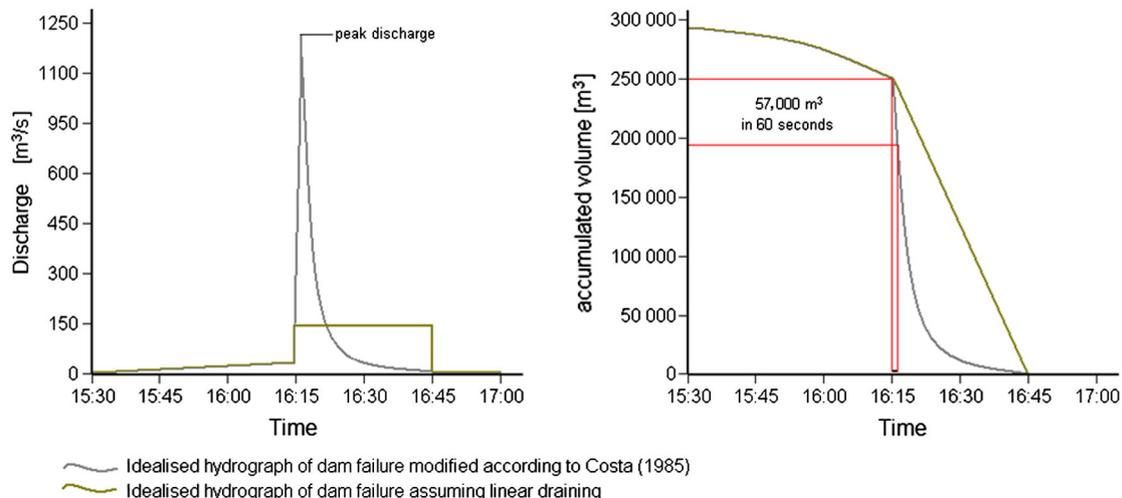
Another point of view concerning the Desná dam failure is represented by a hydrograph describing the change in the flow rate and the decreasing volume of accumulated water between 15:30 h and 16:45 h on 18 September 1916 (Fig. 5). Costa (1985), and later by Tsakiris and Spiliotis (2013), showed that hydrographs describing earthen dam failures are particularly characterised by a steep rising limb and by a steep falling limb, with a peak discharge within minutes to hours, depending on the accumulated water volume, dam characteristics, and failure mechanism.

Fig. 5. Approximate hydrograph of the event (based on the recorded time sequence of the dam failure).

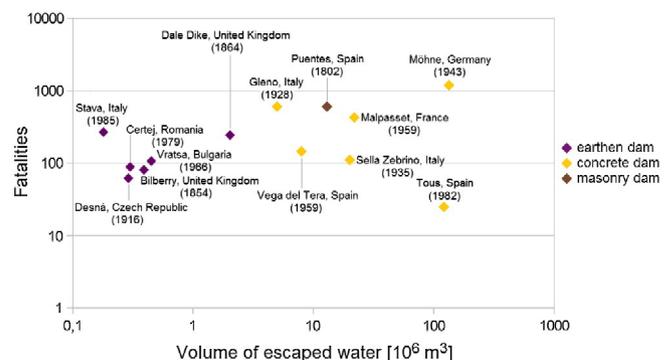
In comparison with recorded floods following dam failures in Europe, the Bílá Desná dam failure claimed a high number of fatalities relative to the volume of escaped water (Fig. 10). The discharged volume of 290,000 m³ and 62 fatalities provide an extremely catastrophic ratio of 4677 m³/victim. From this point of view, the Bílá Desná dam failure is considered one of the worst dam failures ever recorded worldwide. In the regional context of the Czech Republic, no recorded hydrometeorological flood (e.g., the great floods in 1997 and in 2002) claimed such fatalities. According to the number of fatalities, this event is currently ranked among the most catastrophic earthen dam failures in Europe. When we consider the time of the dam failure, this event was ranked as one of the most catastrophic dam failures until 1916 and, therefore, significantly affected the engineering of earthen dams in the entire Central Europe region (Žák, 1996).

Fig. 10. Comparison of the most catastrophic European dam failures. (Data: Harrison, 1974; Costa, 1985; Alcrudo and Mulet, 2004; Peng and Zhang, 2012).
