*Contribution of the collaborative effort of
the Czech WCoE to landslide risk reduction
at the Machupicchu, Peru*

Landslides (2020) 17:2683-2688

Keywords Landslides · Risk reduction · Master plans · Movement monitoring · Machupicchu · Photo monitoring · Peru

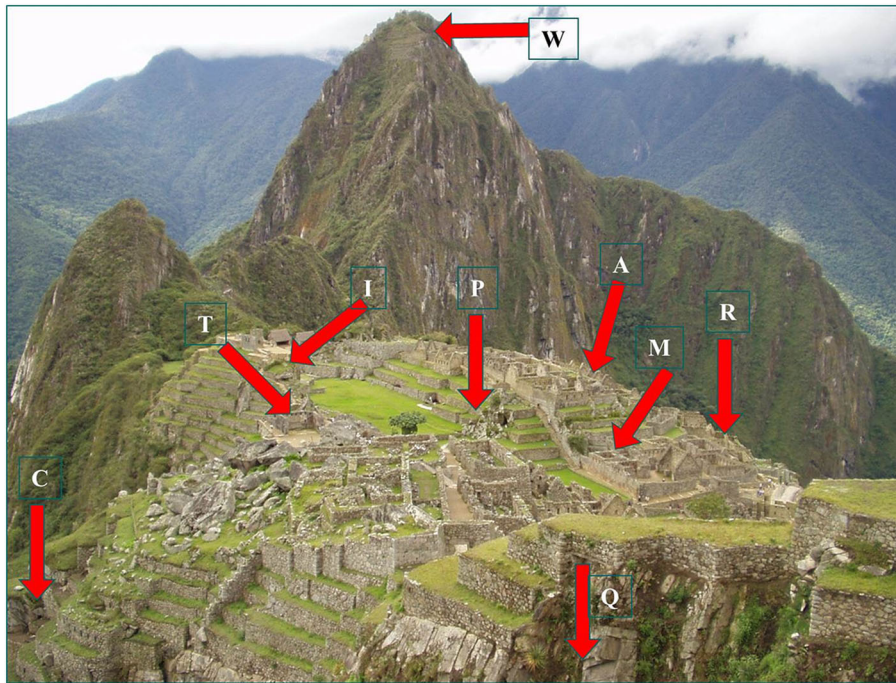
Fig. 1 Location of the dilatometric measurements (view to the N with Waynapicchu Mt. in the background). The flat central part of the Machupicchu site represents the main square between points T and P. The inset shows manual measurements with a rod dilatometer. C = Cave, T = Principal Temple, I = Intiwatana, P = Plaza, W = Waynapicchu, A = Acllawasi, M = Mirador, R = Rodadero, Q = Qhata

The archaeological site is mainly composed of a flat central part with an artificially levelled surface (Fig. 1). This area is probably a former depression between two small parallel crests, which were filled by Inca builders. Both of the crests are located in the source area of a prehistoric rock-slide (Vilimek et al. 2007), and we assume that they may be considered as a former “double crest.” Several large rock blocks were found that could not be reworked by the Incas and open fissures, and caves were identified in several places (Vilimek et al. 2007).

The selected sites for dilatometric measurements (Fig. 1) represent individual outcrops of rock blocks separated by fractures where differential movements of the blocks may lead to damage of the Inca structures or under specific conditions, they may indicate damaging slope movements within the wider area. At the selected sites, nails were attached to the rock surface firstly using special glue due to conservation reasons. Nevertheless, this installation in most cases failed after 2 to 3 years and the nails had to be drilled into the rock. The portable rod dilatometer used (Zvelebil and Stemberk 2000) is capable of detecting a minimum distance change of 10^{-1} mm with a measurement range of 10 mm across a distance of 700 mm.

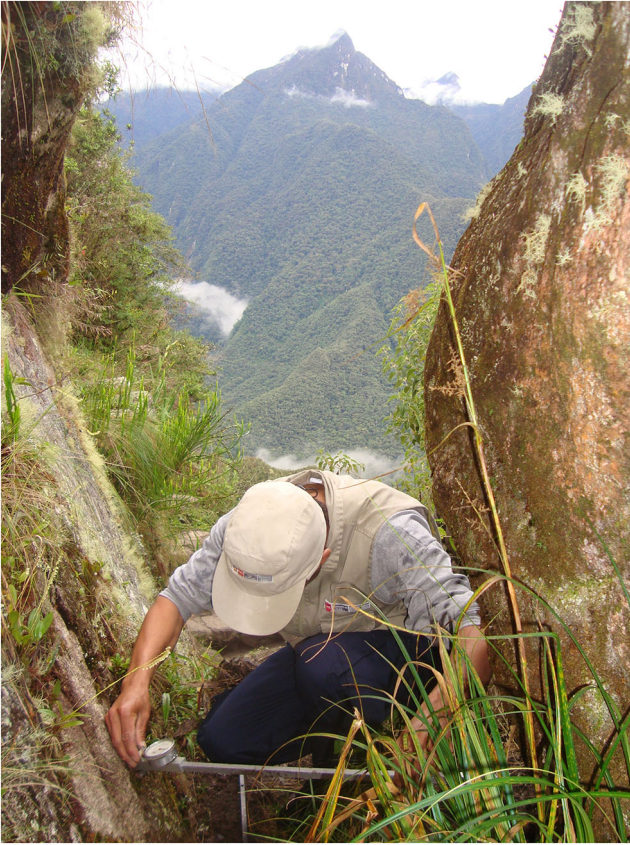
Fig. 2 Dilatometric measurements taken by an expert of the Department of Maintenance and Conservation, DDC-Cusco below the summit of Waynapicchu Mt. (site "W" on Fig. 1)

Since the last visit of the Czech experts in 2015, the dilatometric measurements have been performed independently by the Department of Maintenance and Conservation (Fig. 2). Geologists and technicians are taking the measurements on the 18th of each month, and the results are reported quarterly to the department chair. If the results show significant variations in the measured distances, their possible causes are identified, and if the situation represents a hazard to the archaeological structures, the relevant measures are taken to mitigate. In the worst case, regulation of the movement of tourists within the Machupicchu site is adopted. This was the case of Intiwatana hill, where visitors' entrance has been allowed only between 7.00 a.m. and 10.00 a.m. since May 2019.

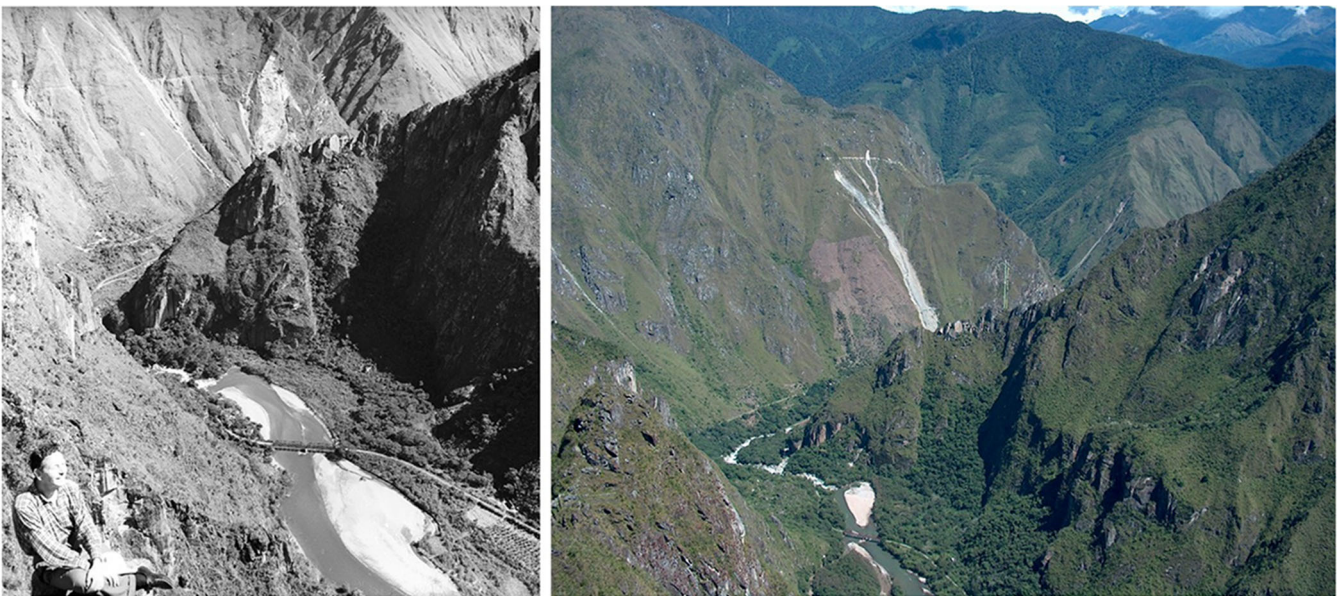
Fig. 3 The historical photograph (left, Ingriš, © Archiv H+Z, Muzeum jihovýchodní Moravy Zlín) showing a small debris flow before 1949 in the same place as the larger event in 2002 (right, photo 2003), which damaged buildings around the hydroelectric power plant in the Urubamba Valley

Historical ground photographs were used for landslide hazard assessment of the slopes surrounding the Machupicchu archaeological site, since they provided information about landslide occurrences preceding the available aerial images from 1963 (Klimes 2013). They were especially helpful in identifying sites of landslide reactivation with long recurrent periods (Fig. 3). Such information led to an increase in the landslide hazard of these sites where the historical photographs extended the available historical record of the landslide occurrences. In some cases (building development around the hydroelectric power plant, Fig. 3), it may be assumed that if the historical information about landslide occurrence has been available and properly considered, the damage caused by the 2002 debris flow could have been avoided or reduced. Comparing historical and recent photographs of the Inca buildings and structures is helpful in evaluating the development of their damage (Fig. 4). In all of the compared cases within the Machupicchu site, no worsening of the damage (e.g., fracture widening, wall collapsing) was observed, which may indicate that the applied conservation and management strategies are appropriate or that the conditions responsible for the original damage did not progress or worsen during the respective time period.
