The evolution of Petrov lake and moraine dam rupture risk (Tien-Shan, Kyrgyzstan)

Bohumír Janský · Zbyněk Engel · Miroslav Šobr · Vojtěch Beneš ·
Karel Špaček · Serguei Yerokhin

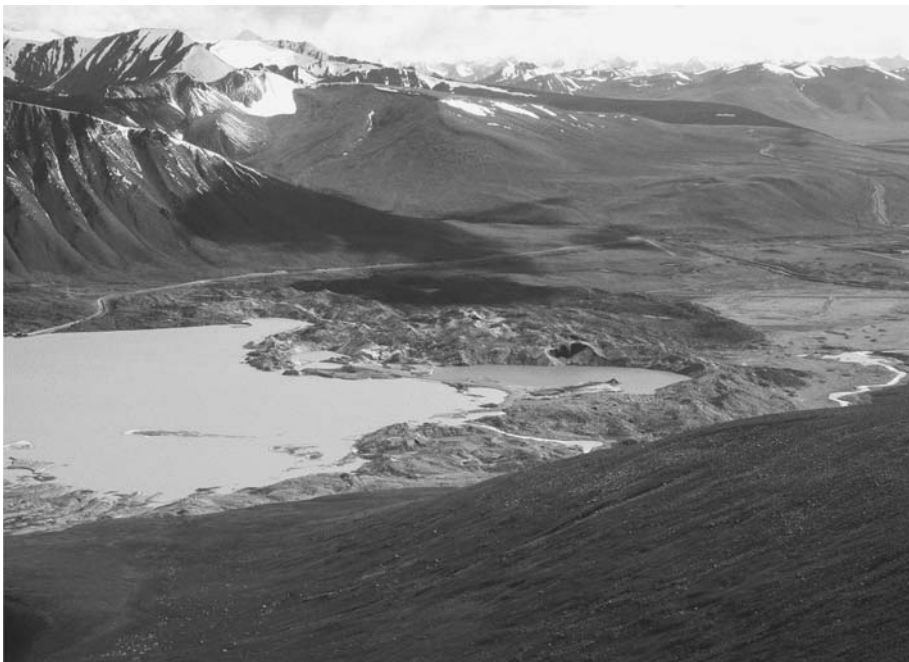
Fig. 1 The moraine dam of Petrov lake with superficial outflow (centre)

The Petrov lake belongs to the moraine-dammed glacial lakes which were formed as a result of a valley glacier retreat (Fig. 1). The lake has been developed between Petrov glacier terminus and the terminal moraine, which is ice-cored. The moraine damming of the lake is from the Little Ice Age (LIA) and consists of typical unconsolidated morainic material (Meiners 1997). The constitution of the moraine thus represents an unstable part of the moraine dam complex and corresponds to the outburst potential of the Petrov lake. Accelerating flow into the lake or melting of ice that constitutes the dam can lead directly to dam failure and subsequent rapid release of water from the lake. Glacial lake outburst floods are common in high-mountain areas around the world. They have been reported from the Alps (Haeberli 1983; Huggel et al. 2002), Karakoram (Hewitt 1982), Himalayas (Richardson and Reynolds 2000; Kattelmann 2003), Tien-Shan (Mayer et al. 2008), Coast Mountains (McKillop and Clague 2003), Rocky Mountains (Walder and Driedger 1995; Clague and Evans 2000) and Andes (Clague and Evans 1994; Hubbard et al. 2005; Vilímek et al. 2005; Carey 2008). Whereas inventories in most of these regions contain

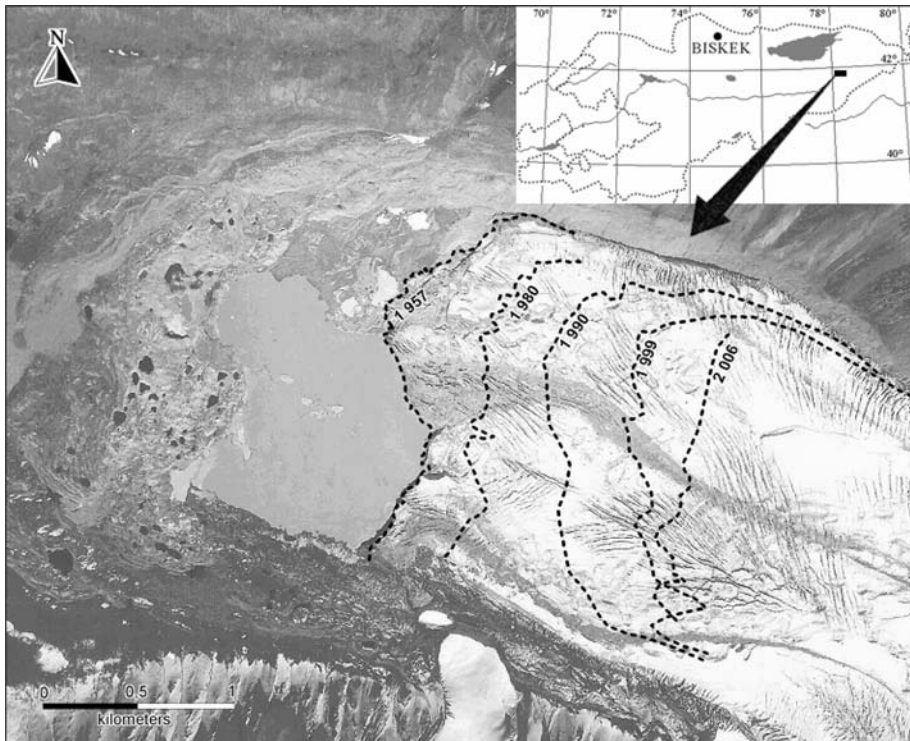
Fig. 2 Fluctuations of the Petrov glacier terminus since 1957

The Petrov lake (3,741 m a.s.l.) is located in the foreground of the Petrov glacier which is situated on the north-western slope of Ak-Shiirak massive in central Kyrgyzstan (Fig. 2). The Ak-Shiirak massive belongs to short mountain ranges of inner Tien Shan that are elevated above wide and shallow valleys formed during the Quaternary glaciations.

Since the end of the 1950s till now, the glacier terminus has retreated continuously (Fig. 2) with an accelerating rate of recession. Table 2 presents the average values for linear retreat of the glacier terminus. Between 1957 and 1980 the surface of the lake increased considerably. It expanded 1.9 times, i.e. a yearly increase of the lake surface area by 0.037 km². The expansion of the surface has persisted. Between 1980 and 1995 the lake grew approximately 0.063 km² every year to reach a size of 2.78 km². The increase in volume was directly related to the decline of the glacier front during this same period. The increase of the lake surface correlates with an increase in volume of the lake basin.

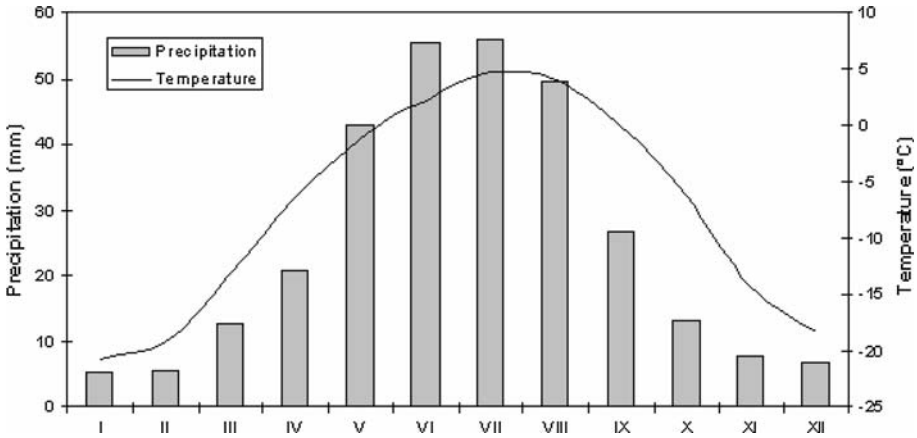
Fig. 3 Average monthly precipitation and temperature (Tien Shan station, 1930–2005)

The region is characterized by a highly continental climate with marked seasonal variation (Fig. 3). In the zone of predominantly west winds, precipitation mainly falls in

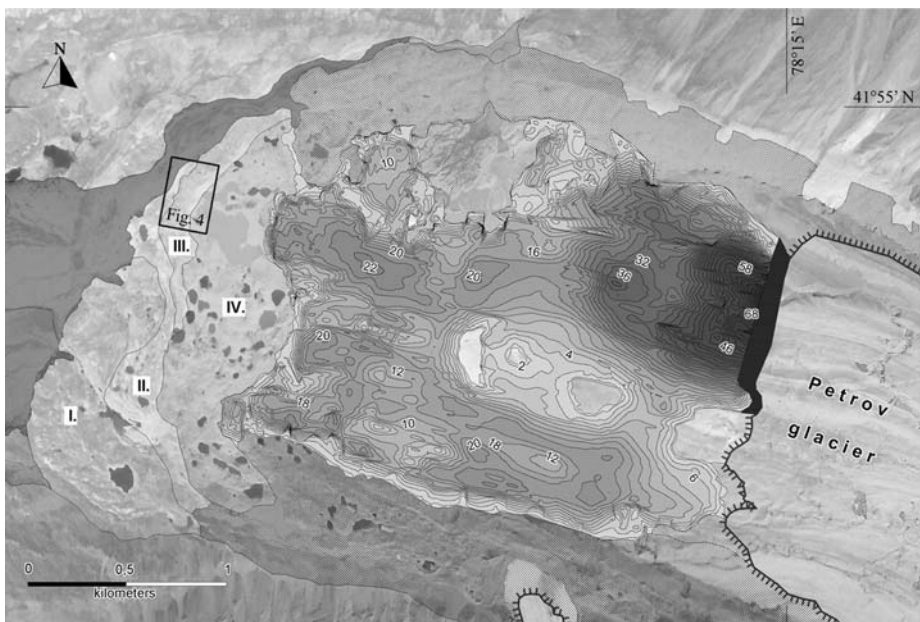
Fig. 4 Morphology of the Petrov lake basin. Explanations: wavy lines—glacial plain, parallel lines—dejection cones, dotted areas—moraines, cross-wise lines—icebergs; isobathic lines—2 m

The maximum depth of Petrov lake measured in July 2006 in front of the glacier terminus was 69.3 m (Fig. 4). According to 2006 fieldwork the lake measures 3.9 km² and its volume is more than 60.3 million m³. All measured morphometric data on the Petrov lake basin are presented in Table 4.

Resistivity cross sections positioned on the basis of the resistivity tomography measurements give information about the conditions in the narrowest part of the dam (Fig. 4). The resistivity values vary between one thousand (bouldery debris, moraine) and hundreds of thousand ohms (ice blocks and rocky debris bonded by ice). The interpretation is based on the theoretical values for individual material types. Resistivity values measured in the uppermost part of the moraine dam point at the presence of buried ice with a thickness of up to 20 m, gradually declining to the depth of ice in the dam. The blocks are overlain by rocky debris showing a thickness of mostly between 2 and 5 m. Ice core is not homogeneous in the entire dam axis. The sections at 1,000 m and 1,050 m of the profile P1 show marked disturbances of the measurements (Fig. 6). We propose that lower resistivity values are related to reduced ice content in these zones. Cross sections also identified an area with very high resistivity in the terminal part of the moraine complex.

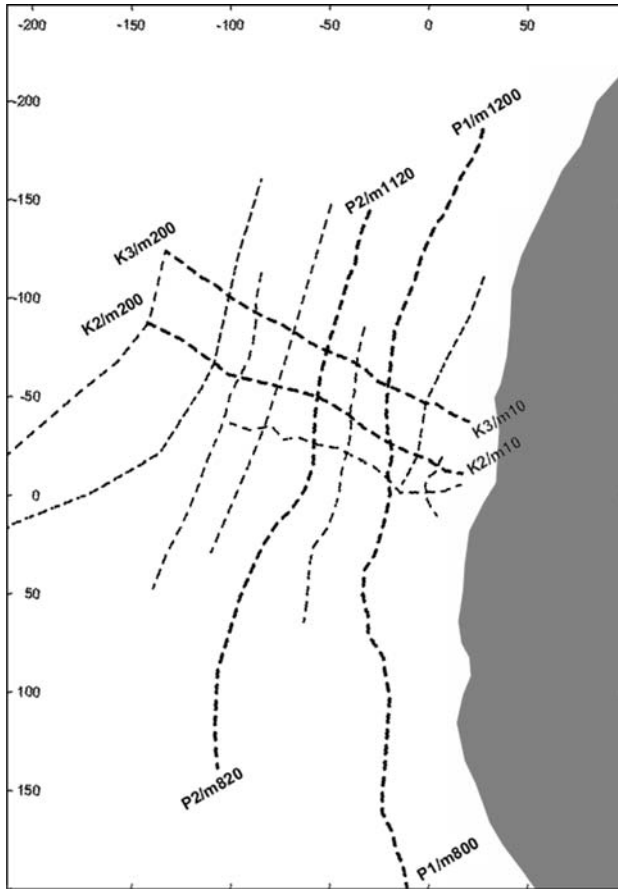
Fig. 5 Localization of geophysical soundings in the narrowest segment of the moraine dam

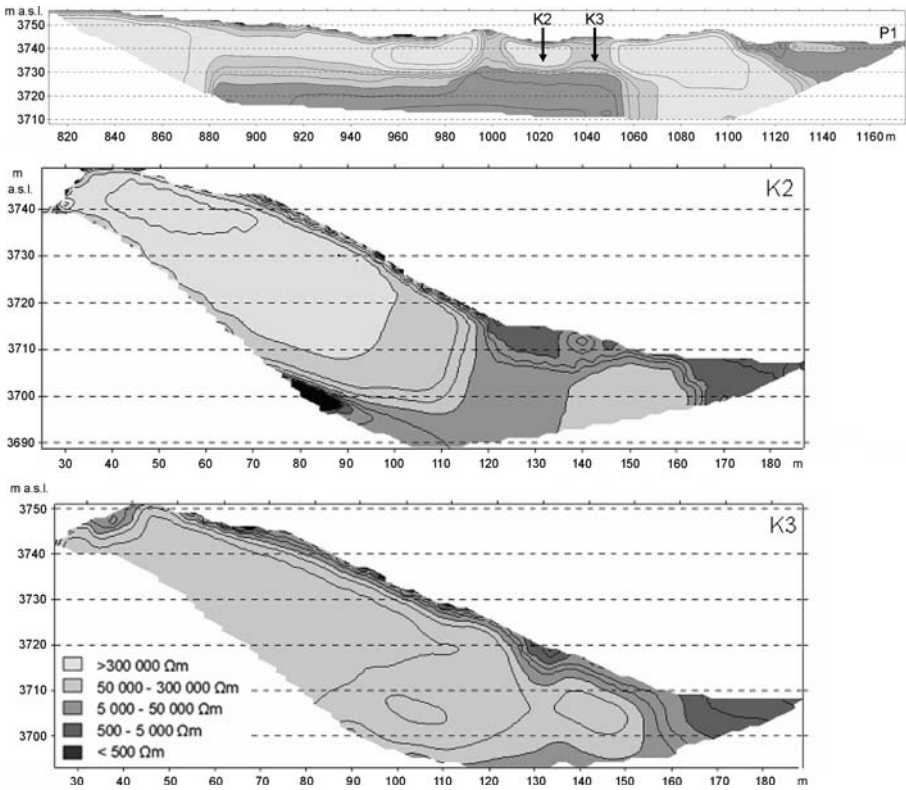
Fig. 6 Resistivity tomography—the longprofile P1 and cross-section profiles K2, K3 (position in Fig. 5, explanations in Fig. 6: profile K3)

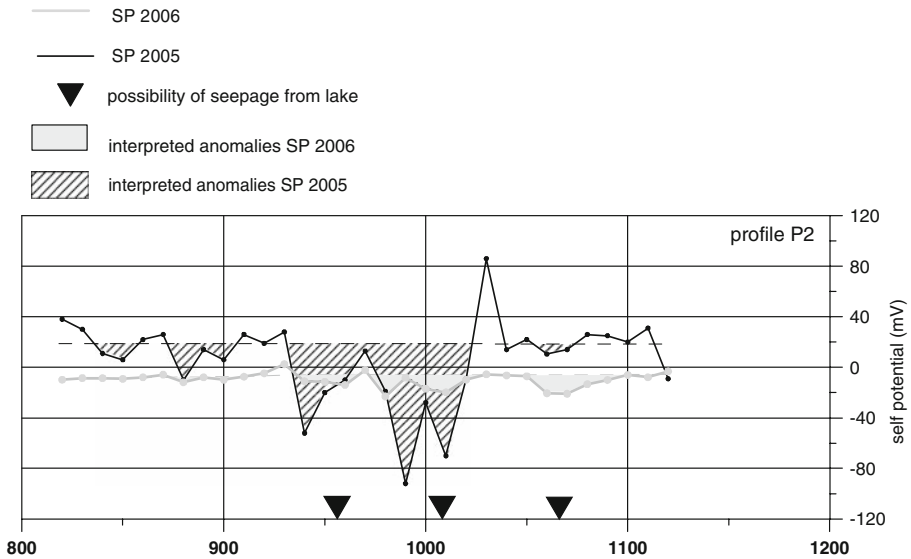
Fig. 7 Spontaneous polarization measurements: profile P2

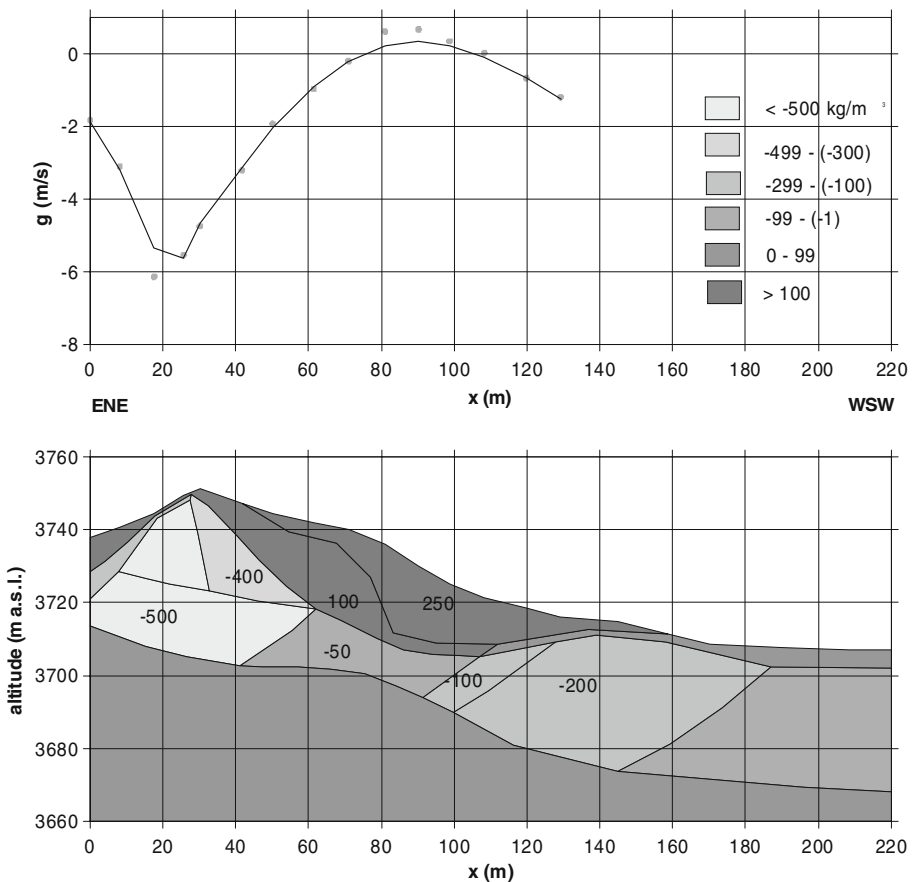
Fig. 8 Gravimetry and density model: profile K2

Gravimetric survey was used in the majority of the profile grid, covering the dam part of interest. The resulting interpretation was based on residual Bouguer anomaly, which best informs on local density heterogeneities in the dam body (for example, ice blocks, increased thicknesses of debris, etc.). This residual Bouguer anomaly was calculated by deducting the measured values from the regional field. The results show the measured density minimums at the locations of “ice cores” detected by resistivity methods. The hypothesis of ice cores was also confirmed by compilation of density models of transverse gravimetric profiles (Figs. 8 and 9). All models suggest that a marked anomalous body with reduced bulk density occurs in the upper part of the moraine dam. Another similar body corresponding to buried ice occurs in the frontal part of the moraine dam.

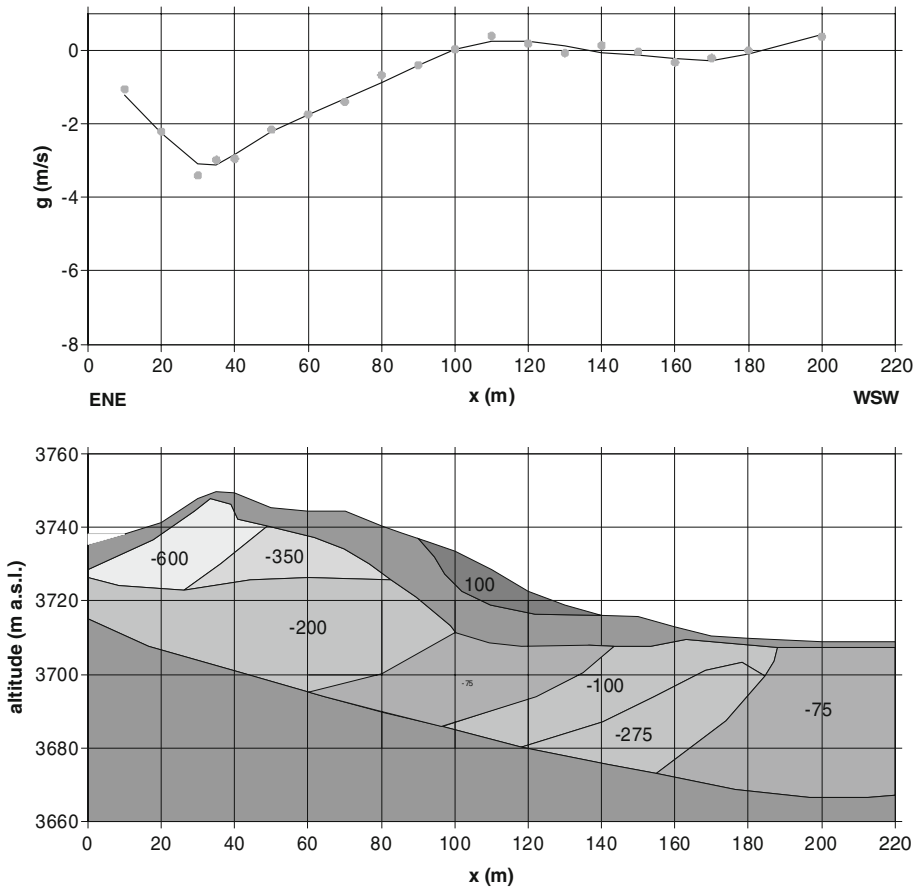
Fig. 9 Gravimetry and density model: profile K3. *GPR*, ground penetrating radar; *GPS*, global positioning system; *SP*, spontaneous polarization
