Glacial Lake Outburst Floods (GLOFs) in the Cordillera Huayhuash, Peru: Historic Events and Current Susceptibility

Keywords: glacial lakes; GLOFs; GLOF susceptibility; moraine-dammed lakes; Cordillera Huayhuash; Andes; Peru

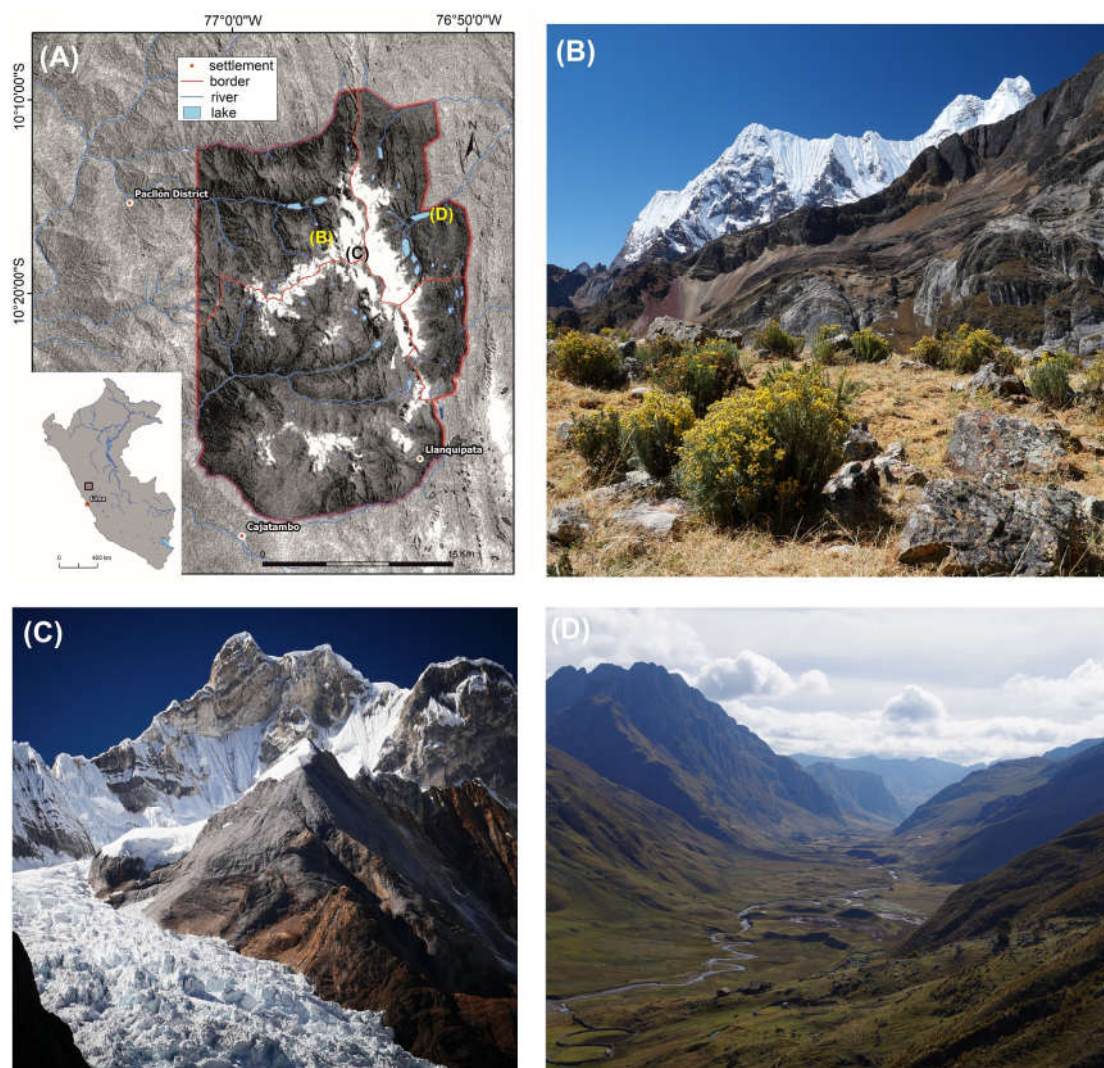
Figure 1. Study area. (A) The location of the study area Cordillera Huayhuash in Peru; (B), (C) and (D) diverse environmental conditions in different parts of the study area (for location see (A)). Field images were taken in 2018 and 2019 by AE.

The Cordillera Huayhuash is located about 200 km north of Peru's capital, Lima, and about 50 km south east from the Cordillera Blanca (10.3° S, 76.9° W; Figure 1); indeed, the Cordillera Huayhuash may be interpreted as the southern continuation of the Cordillera Blanca [28]. It is the second highest mountain range in Peru with Nevado Yerupajá reaching 6617 m a.s.l. Its main, largely glacierized spine stretches 25 km in a roughly north-south direction with two lateral ridges, each extending about 10 km to the west. The geological setting of the area is characterized by Cenozoic volcanic rocks (30–15 and 6 Ma) underlain by Cretaceous carbonates and quartzites and the Late Cretaceous Coastal Batholith, with a series of Late Miocene granitic plutons [28]. The Cordillera Huayhuash has been shaped by Quaternary glacial and fluvial erosion forming valleys perpendicular to the main ridge.

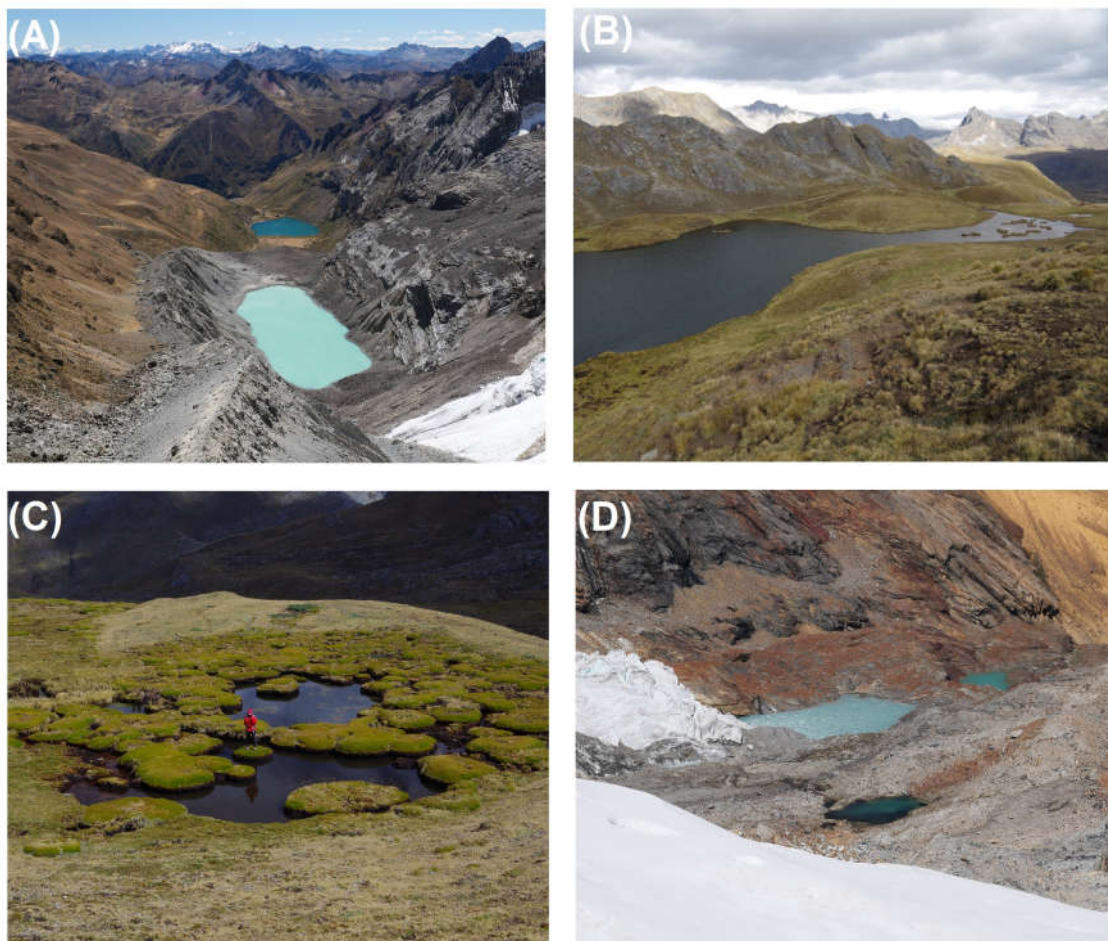
Figure 2. Different lake types present in the Cordillera Huayhuash. (A) Moraine-dammed lakes Barrosacocha (upstream, W006) and Rasaqcocha (downstream, W005); (B) large bedrock-dammed Lake Huaracacocha (E012); (C) an example of relict ('pampa' type) lake near the Siula Punta; and (D) a small moraine- (in front) and two bedrock-dammed lakes (one of which is proglacial) near the Rasac Punta. All images were taken in 2018 and 2019 by AE.

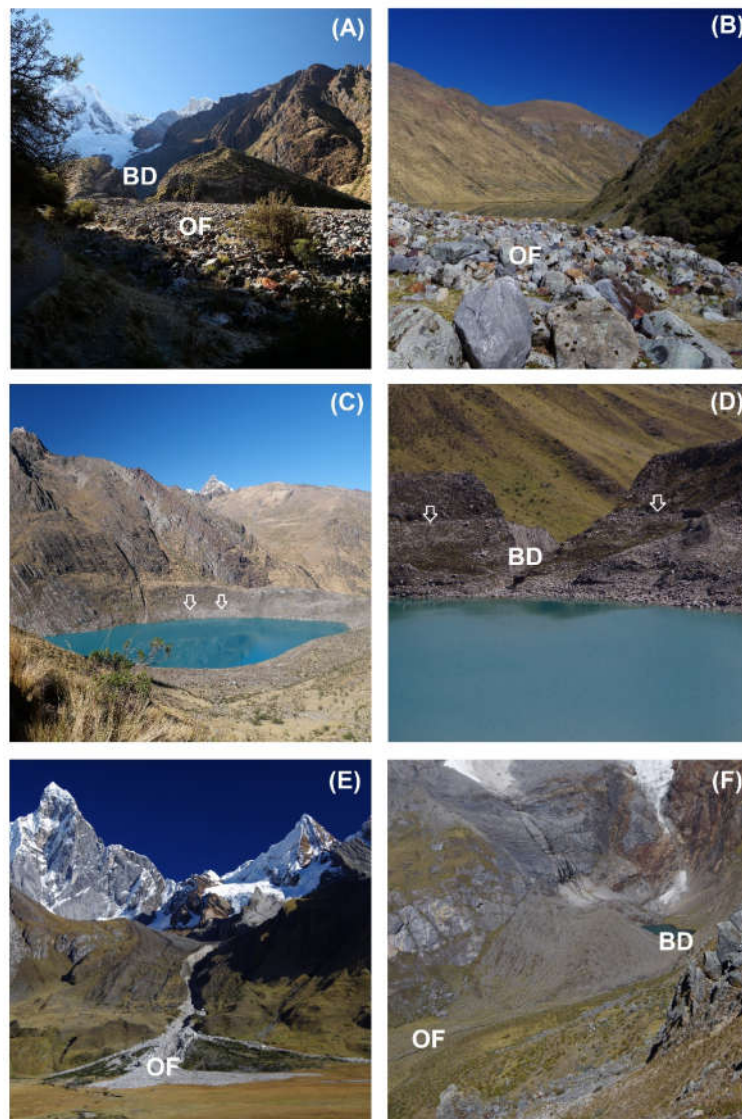
Figure 3. Examples of diagnostic features of past glacial lake outburst floods (GLOFs) in the Cordillera Huayhuash. (A) Upstream view on breached moraine dam (BD) of Lake Solteracocho (in centre background) with outwash fan located directly downstream from the dam (OF); (B) downstream view over this outwash fan (OF), the largest boulders are > 2 m in diameter; (C) visible evidence of Solteracocho pre-GLOF lake water level (arrows; GLOF in 1932); (D) downstream view

through breached moraine dam (BD) of Lake Gangrajanca and pre-GLOF lake water level (arrows); (E) fresh outwash fan (OF) of recent ambiguous event associated with lake Chaclan; (F) breached moraine dam (BD) and partly vegetation-covered outwash fan (OF) of Unnamed lake (W032). All images were taken in 2018 and 2019 by AE.

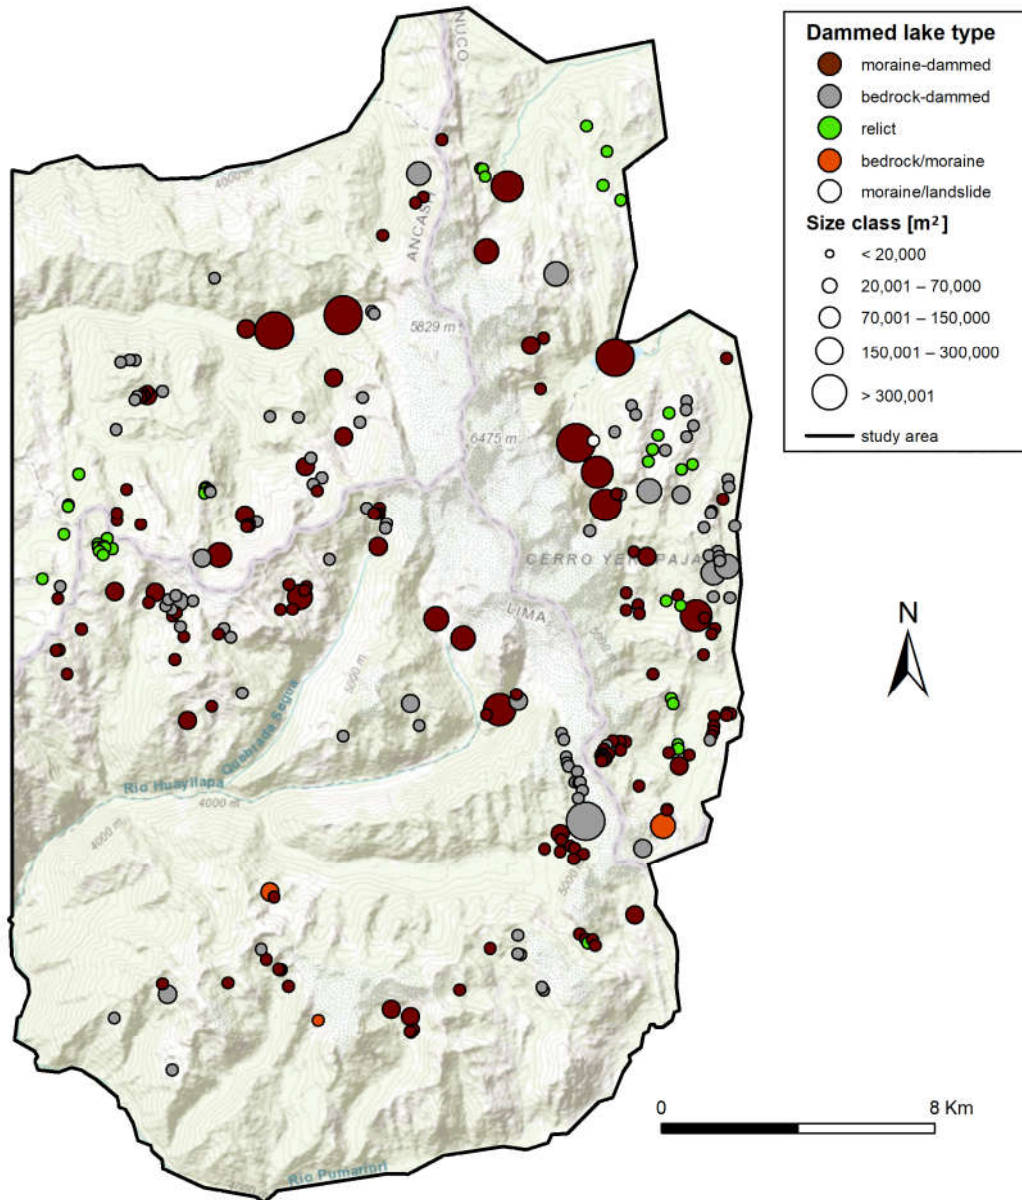
Figure 4. Lake inventory of the Cordillera Huayhuash with lake dam types (see Section 2.1 and Figure 2) and lake sizes. Background map: [40].

We have mapped 270 lakes (a total area 6.31 km²), of which 167 (total area 3.16 km²) are located in the western part of the study area, and 103 (total area 3.15 km²) are located in the eastern side (see Table 2; Figure 4). A total of 137 lakes are classified as moraine-dammed, 92 as bedrock-dammed, 37 are relict, 3 lakes have combined dam (bedrock + moraine) and one lake is dammed by moraine in combination with debris flow deposition. Basic characteristics of mapped lakes with regard to area, elevation, presence/absence of surface outflow, glaciers in the catchment, and direct contact with glacier ice are shown in Table 3; for the lake axis orientation, see Supplementary Materials Table S1.

Comparison of the two most common lake types shows that bedrock-dammed lakes were formed in higher altitudes and are more than two times smaller on average than moraine-dammed lakes. However, no relation between lake area and lake level elevation was revealed ($R^2 = 0.164$). The catchments of the bedrock-dammed lakes are mostly deglaciated whereas most of the moraine-dammed lakes host glaciers in their catchments.

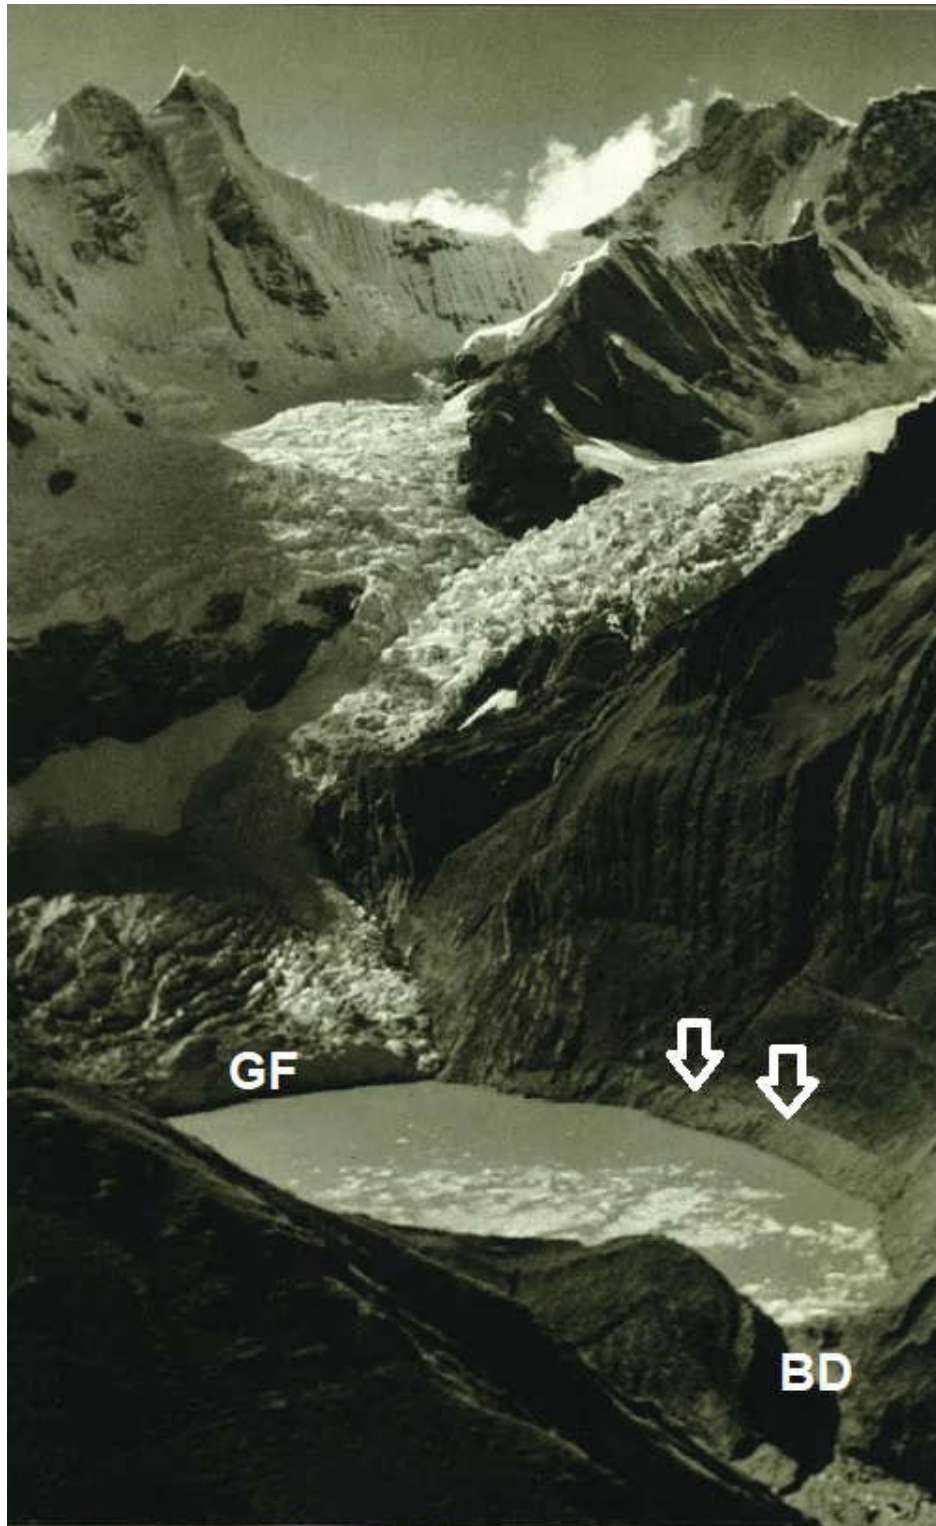
Figure 5. Lake Solteracocha in the 1930s (most likely in 1936), shortly after dam failure in 1932. Breached moraine dam (BD) is visible in lower right corner; arrows indicate pre-GLOF lake water level (also visible on Figure 3C). Note that the lake was still proglacial at the time (GF—glacier front). Image modified from [9].

Little is known about the preconditions and triggers of these GLOFs. Historical field images from Austrian–German expeditions carried out in the 1930s, as well as satellite remote sensing imagery, nevertheless reveal some details of these events. Strikingly, most of the current glacier-detached, large moraine-dammed lakes were proglacial at the time of the GLOF (often proglacial in the first post-GLOF image available). For instance, Lake Solteracocha was proglacial several (tens of) years after dam failure (see Figure 5).

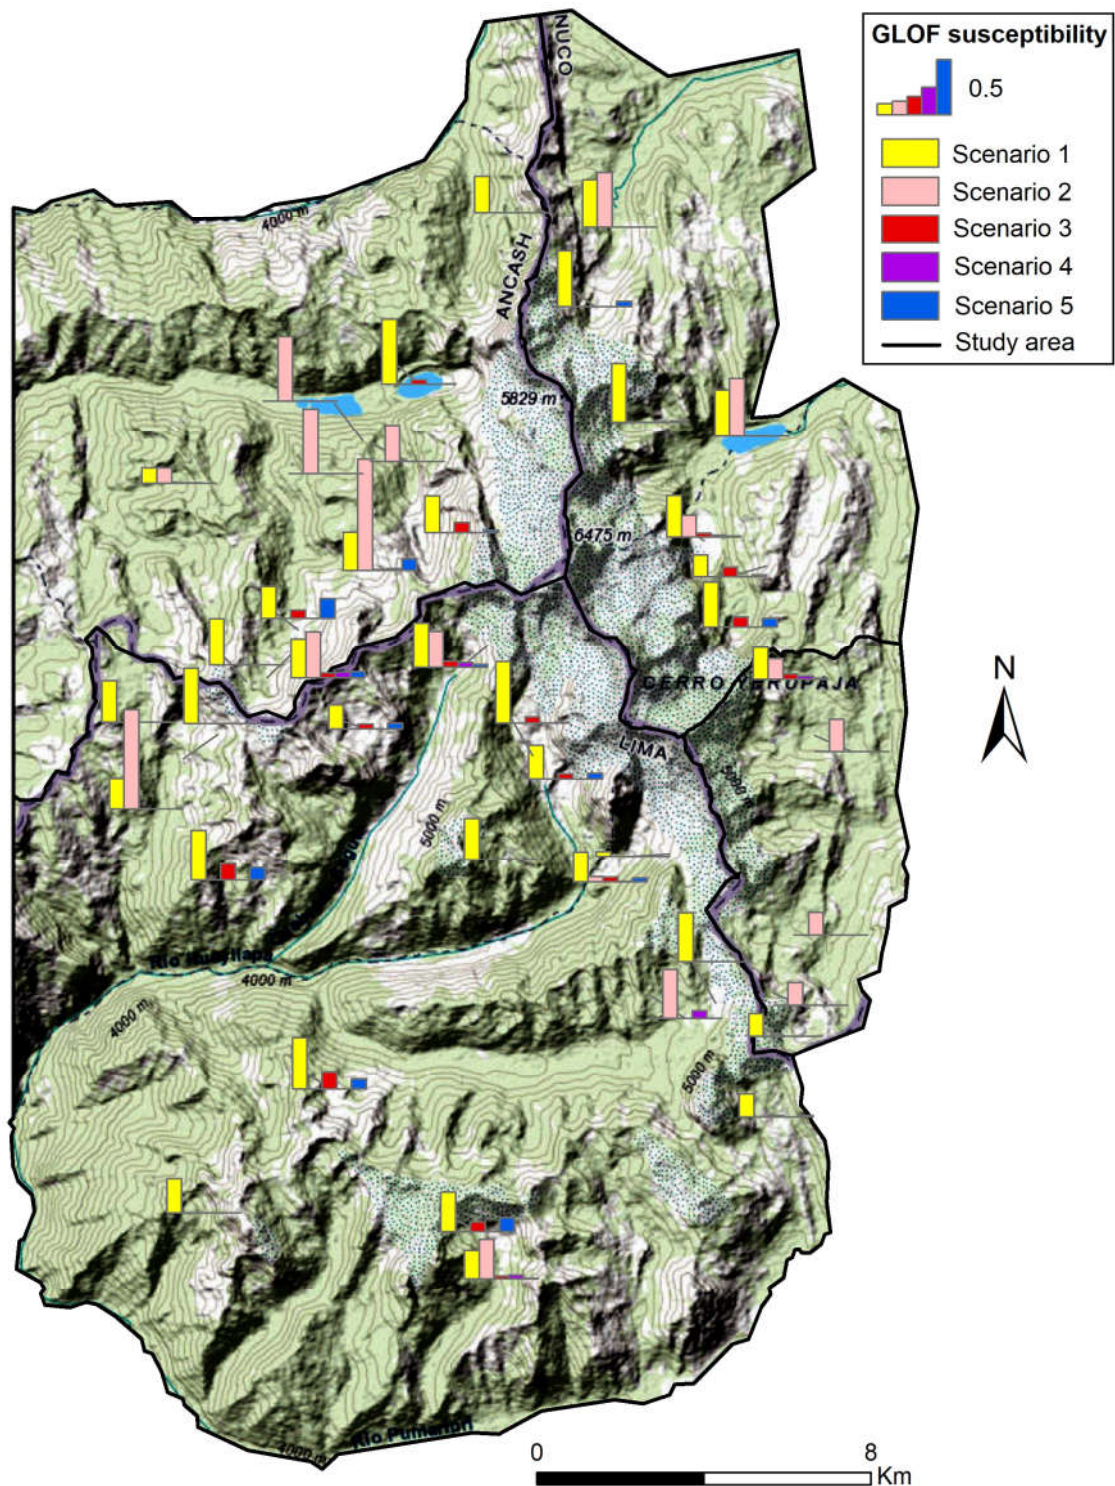
Figure 6. Map of the GLOF susceptibility of 46 large lakes (>20,000 m²) of the Cordillera Huayhuash. Background map: [40].

The vast majority of lakes of the Cordillera Huayhuash have low susceptibility to generating GLOFs (Figure 6; Table S2). Table S2 further shows that the most frequently expected GLOF scenario in the Cordillera Huayhuash is the dam overtopping due to rapid slope movement into the lake

(Scenario 1), followed by the scenario of dam overtopping due to flood wave impact from a lake located upstream (Scenario 2). The susceptibilities of other scenarios rarely exceeded the threshold of negligible values. Out of the 46 evaluated lakes, only two exceeded high susceptibility thresholds, both in Scenario 2. These are Lake Tsacra (W007) and Lake W014. The width of the calving front exceeds the lake width in both cases, which is the main factor increasing susceptibility to GLOF (together with surface outflow, i.e., 0 m dam freeboard). Five lakes were found to have medium GLOF susceptibility for Scenario 1 and four other lakes for Scenario 2. Dam failures (Scenarios 3, 4 and 5) appear unlikely in the Cordillera Huayhuash, considering the fact that the majority of steep-sloped moraine dams that retain large lakes have already failed (see Sections 3.2 and 4.2).
