## Journal of Maps

# Glacier-related landforms and glacial lakes in Huascarán National Park, Peru

Vít Vilímek<sup>a\*</sup>, Jan Klimeš<sup>b</sup> and Lucie Červená<sup>c</sup>

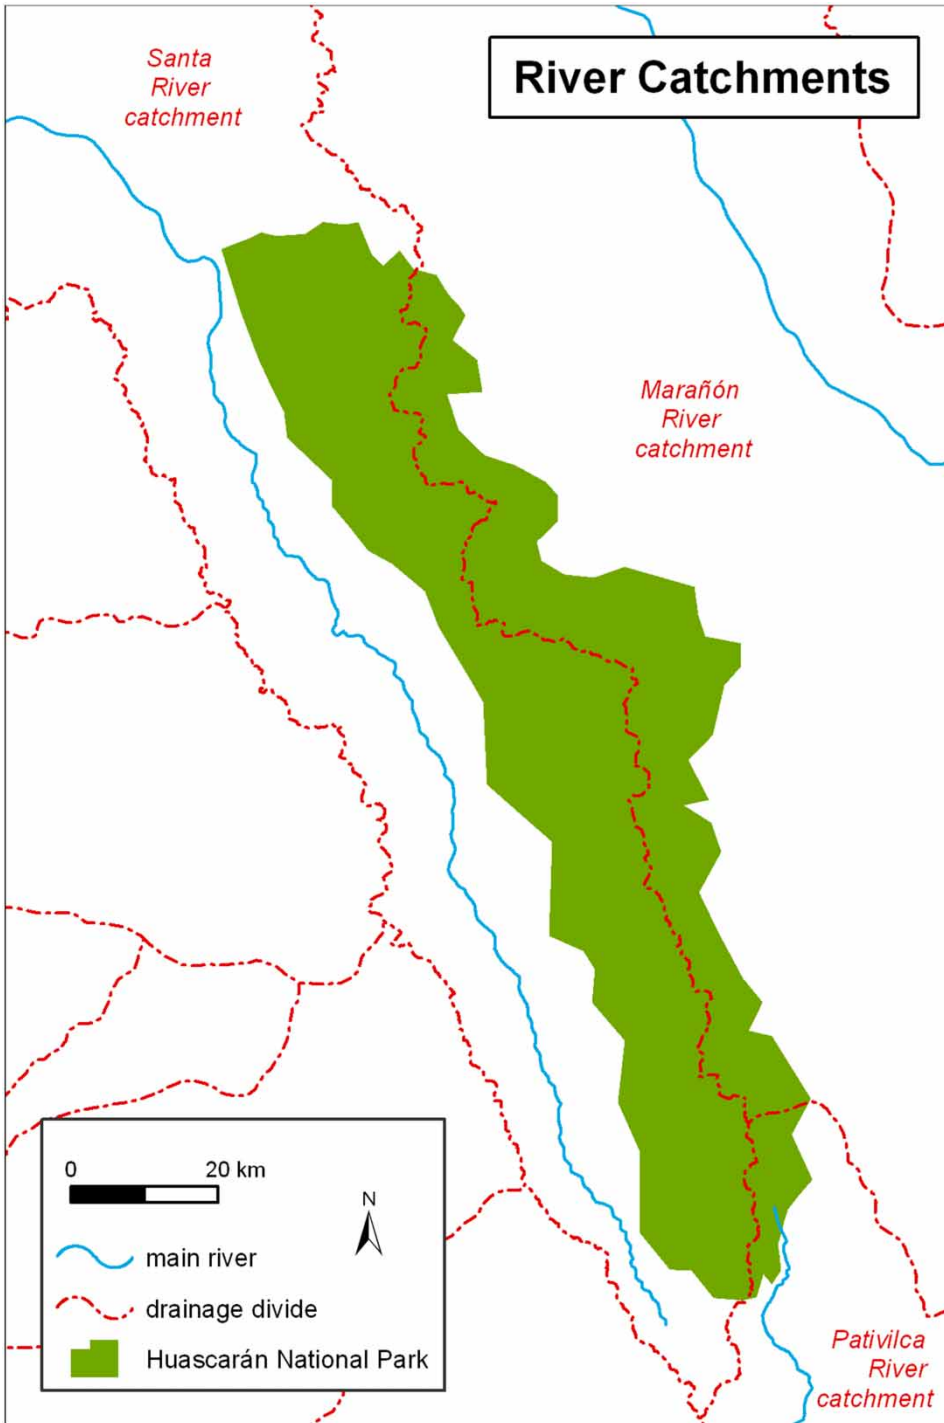
Figure 1. Huascarán national park divided into three catchments.

The total number of mapped features is shown in Table 1 with respect to the main river catchments of the Cordillera Blanca mountain range (Santa River, Marañon and Pativilca catchments – see also Figure 1). Most of the lakes are located behind bedrock or moraine dams (581 and 588, respectively); moreover, an additional 500 lakes are of a combined origin (moraine + bedrock dam). Altogether this represents 1669 out of 2370 lakes (70%). The second largest group is
